Facility Condition Assessment

Dr. Harry L. Halliwell Memorial School | *October 2016*

Address: 358 Victory Highway, Slatersville, RI 02876

Report Generated: October 06, 2016

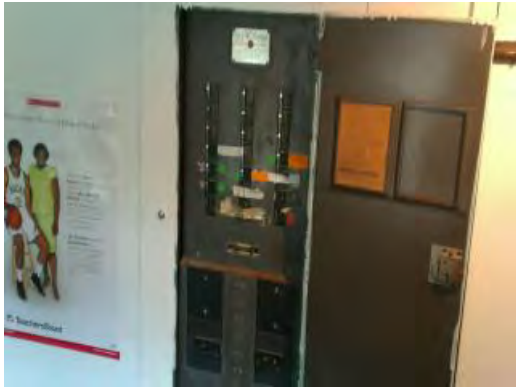
Aged Panel

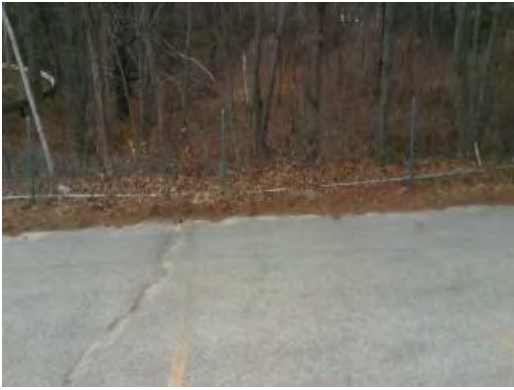
Deficiency	Category	Qty	UoM	Priority	Repair Cost	ID
Fencing Requires Replacement (4' Chain Link Fence) Note: Fence is falling down.	Capital Renewal	360	LF	3	\$23,116	1112
Septic System Has Failed And Requires Replacement	Capital Renewal	1	Ea.	3	\$755,436	2847
Traffic Signage Is Required Note: Upgrade school zone signs	Traffic	7	Ea.	3	\$264,403	4452
Backstops Require Replacement Note: Backstops Require Replacement	Educational Adequacy	1	Ea.	4	\$28,674	28524
Exterior Basketball Goals Require Replacement	Capital Renewal	4	Ea.	4	\$30,520	1110
Exterior Basketball Goals are Required Note: Exterior Basketball Goals are Required	Educational Adequacy	1	Ea.	5	\$5,878	28767
The school lacks a paved play area. Note: The school lacks a paved play area.	Educational Adequacy	1	Ea.	5	\$48,503	28025
Sub Total for System		7	items		\$1,156,530

Fence Falling Down

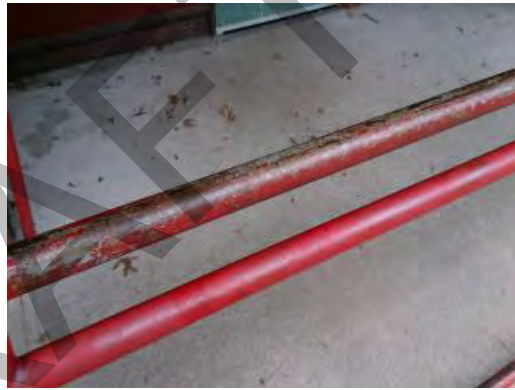
Deficiency	Category	Qty	UoM	Priority	Repair Cost	ID
Handrail Requires Repainting Note: Railings throughout the campus are worn and in need of repainting.	Capital Renewal	500	LF	4	\$5,194	1312
Media Center does not meet size standard Note: Library/Media Center does not meet required RI standard for space size. (Std=2020 sf, Current=1600 sf)	Educational Adequacy	420	SF	4	\$281,005	53241
Sub Total for System		2	items		\$286,199	
Sub Total for School and Site Level		9	items		\$1,442,729

Typical Worn Handrail

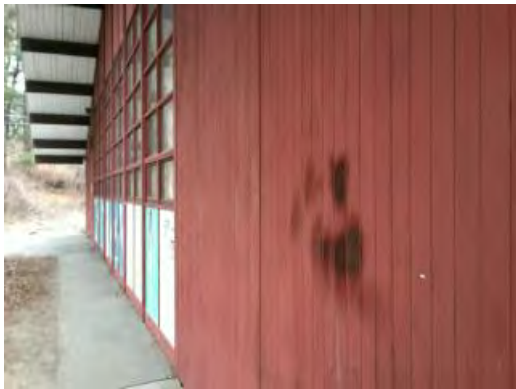
Stained Wood Exterior

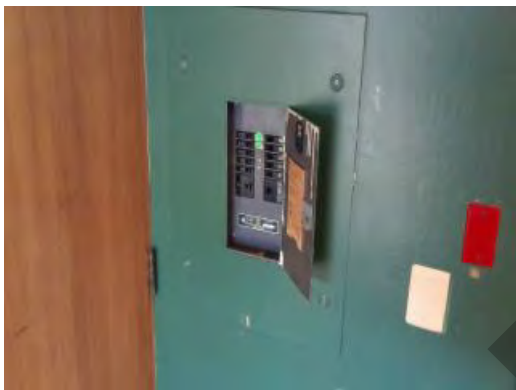
Aged Panelboard

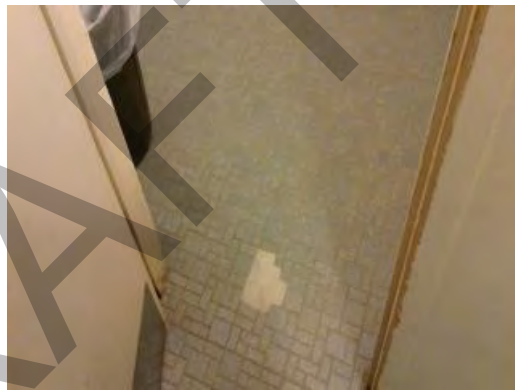
Missing Tiles

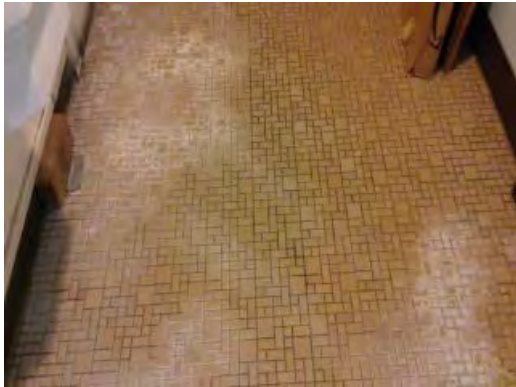
Stained And Faded VCT

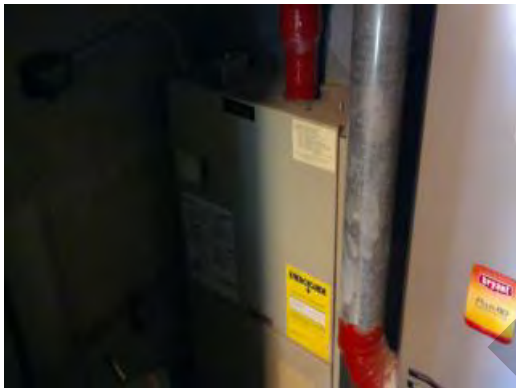
Corroding Furnace

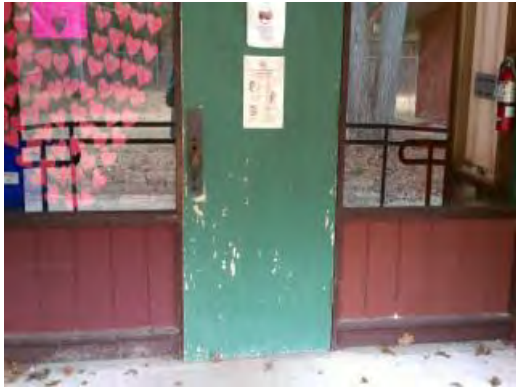
Chipped And Faded Exterior Door

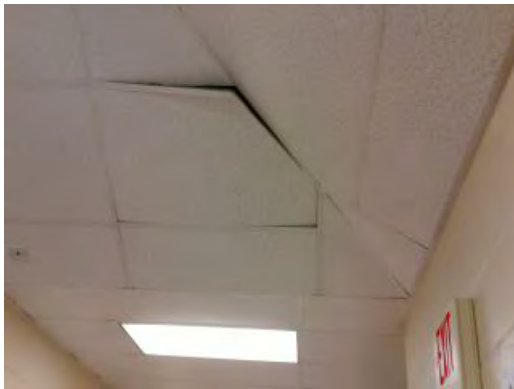
Ceiling Tile Falling Out Of Grid

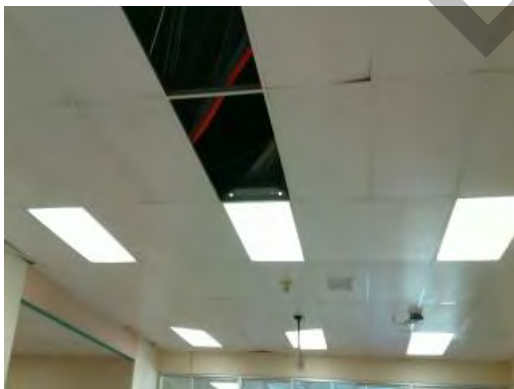
Missing Or Stained Ceiling Tiles

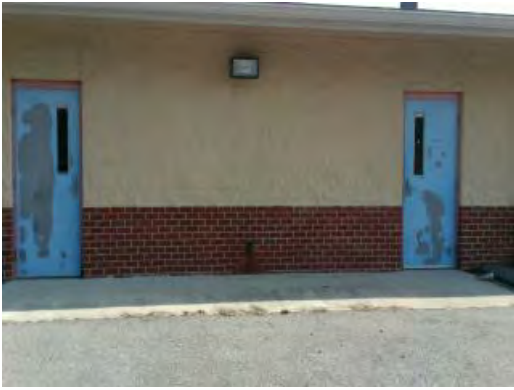
Typical Worn Metal Exterior Doors

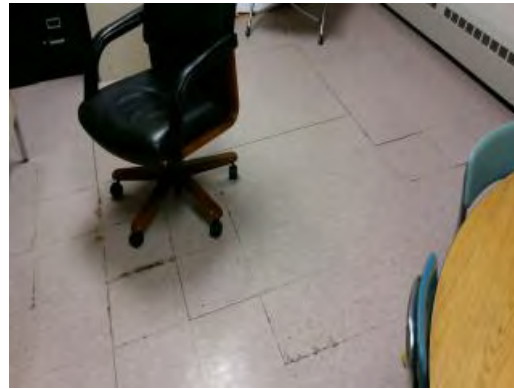
Typical Worn VCT

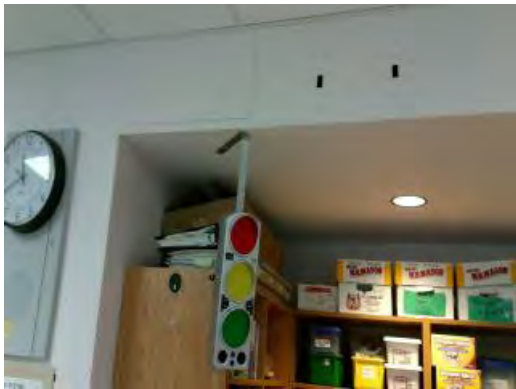
Cracks In Painted Walls

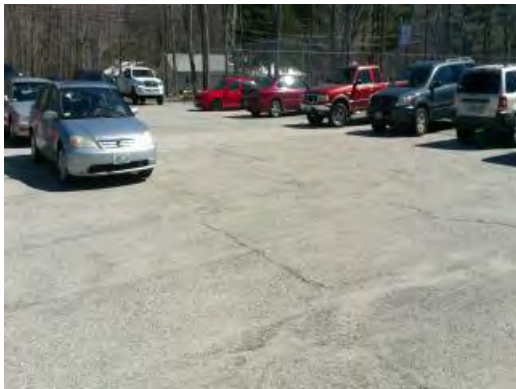
Site - Weathered Asphalt Paving

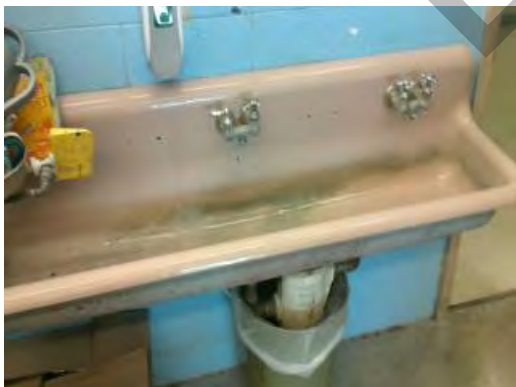
Main Building - Stained And Leaking Trough Sink Fixture

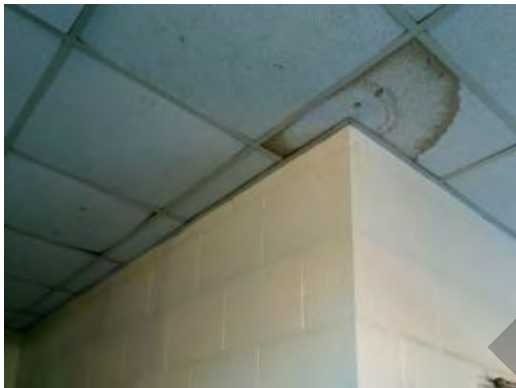
Main Building - Stained Ceiling Tiles

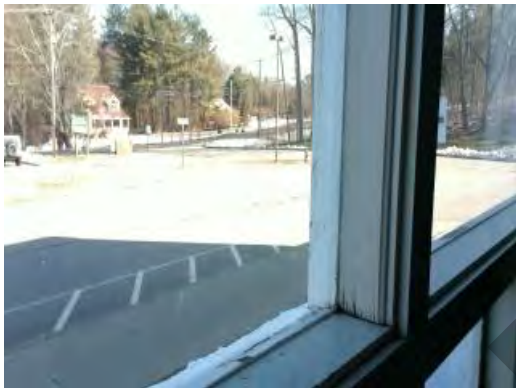
Main Building - Cracking Wood Framed Window

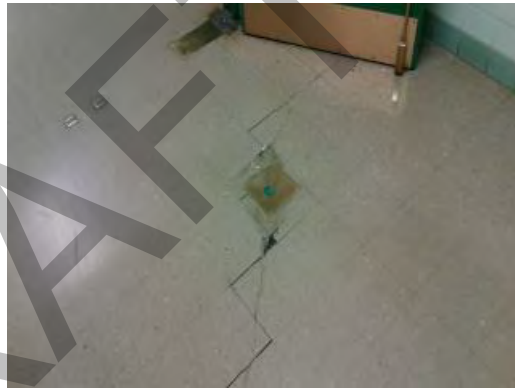
Main Building - Cracked And Separating 9x9 Tile

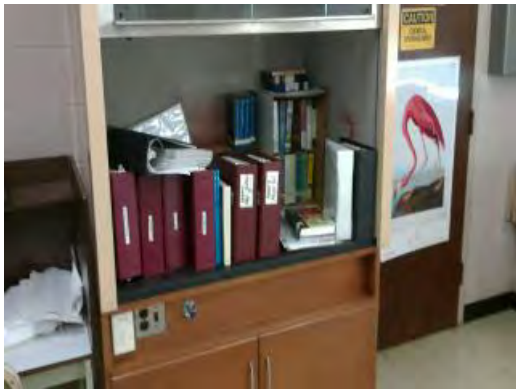
Main Building - Inoperable Fume Hood Used As Storage

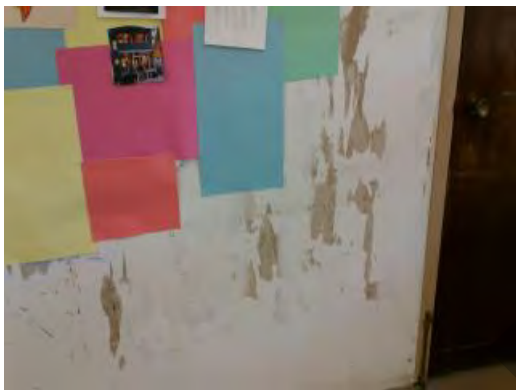
Main Building - Damaged Painted Classroom Wall

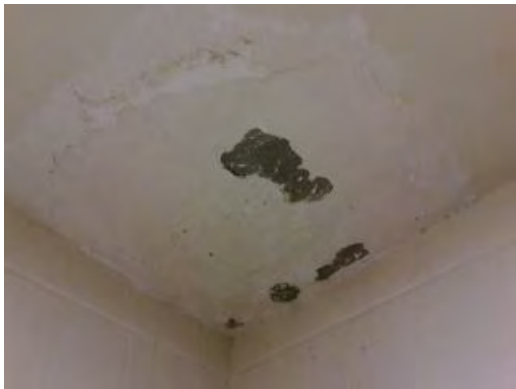
Main Building - Paint Peeling And Bubbling On Ceiling

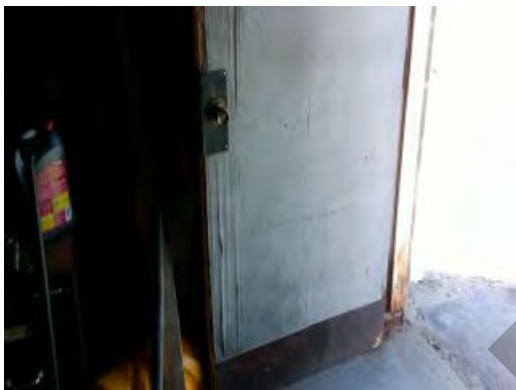
Maintenance Shed - Damaged Exterior Door

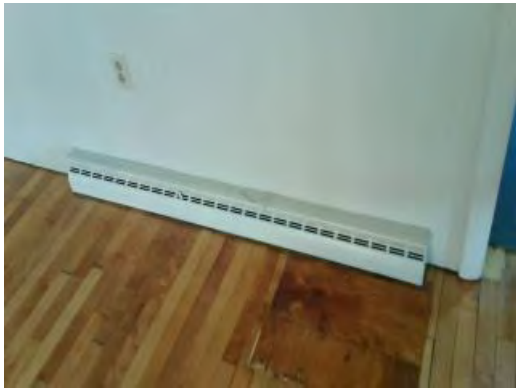
Damaged Baseboard Heater

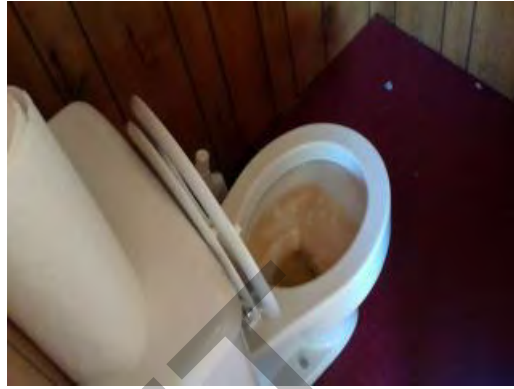
Aged And Stained Toilet

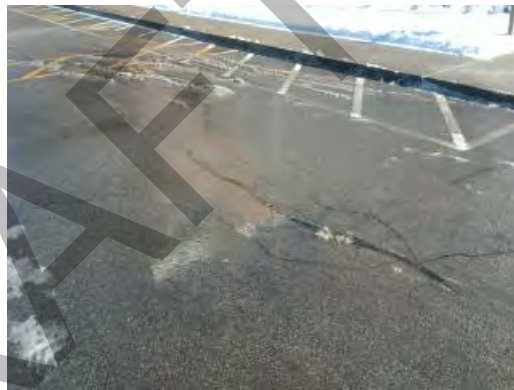
Cracking Asphalt At Main Drain

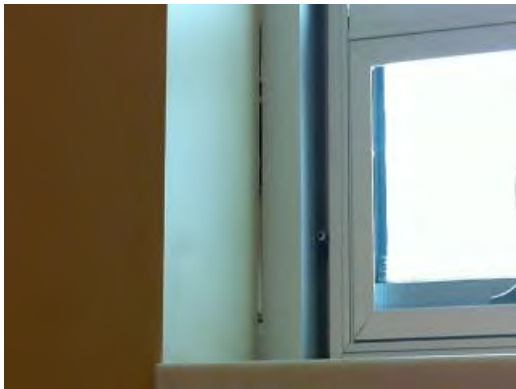
Sealant Failing At Window

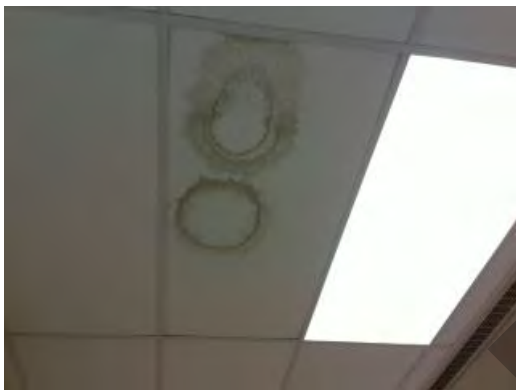
Stained Ceiling Tile

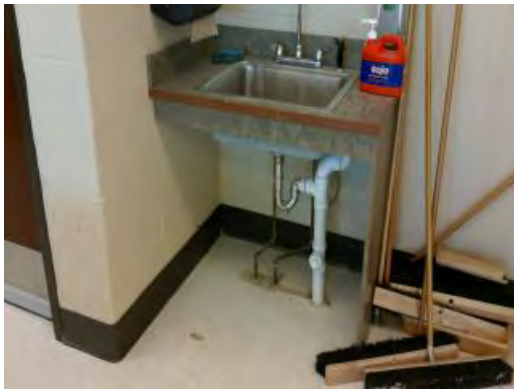
Pipe Missing Insulation

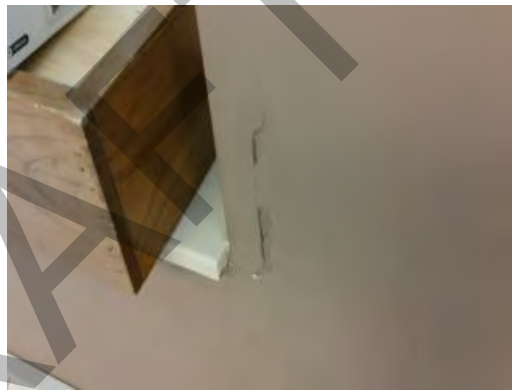
Damaged Gypsum Board Wall

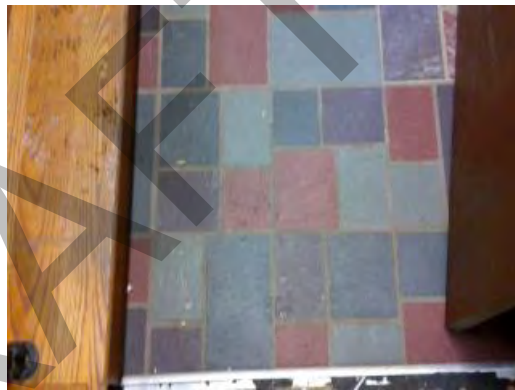
Worn Vinyl Tile
