# North Smithfield

# Facility Condition Assessment

Dr. Harry L. Halliwell Memorial School, located at 358 Victory Highway in Slatersville, Rhode Island, was built in 1957. It comprises 41,175 gross square feet. Each school across the district was visited three times during the Facility Condition Assessments by three teams of specialists in the spring/summer of 2016.

North Smithfield - Dr. Harry L. Halliwell Memorial School

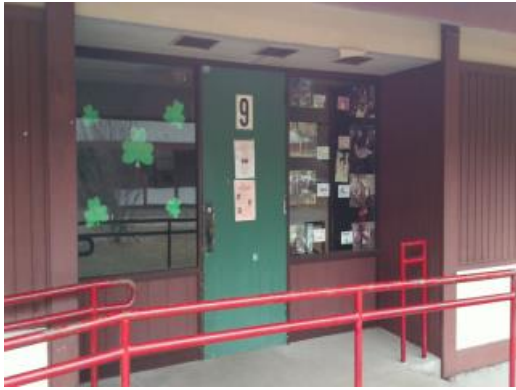
Exterior Door

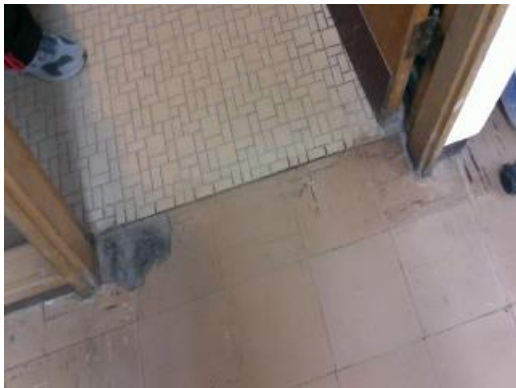
Typical Worn VCT

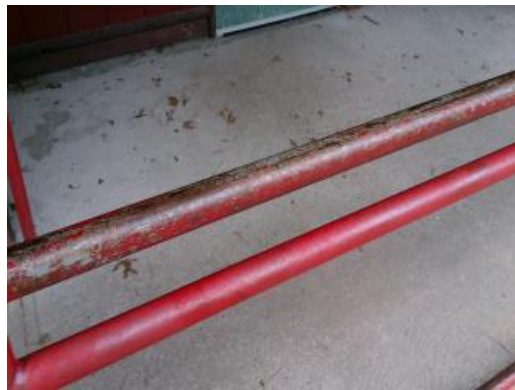
Typical Worn Handrail

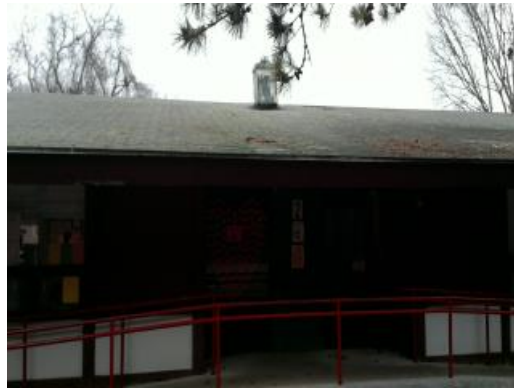
Shingles Missing From Building 2 Roof

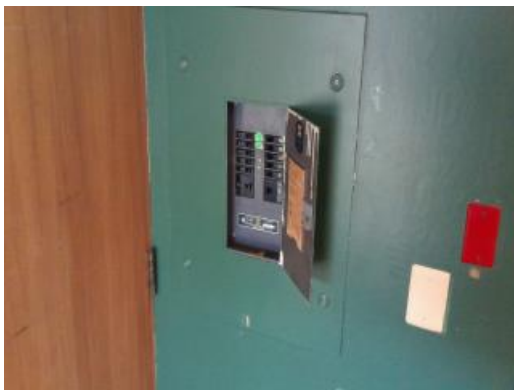
Aged Panelboard

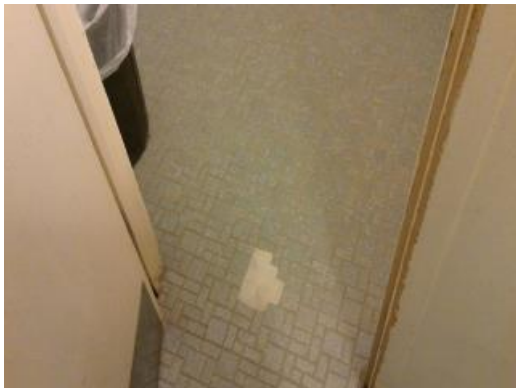
Missing Tiles

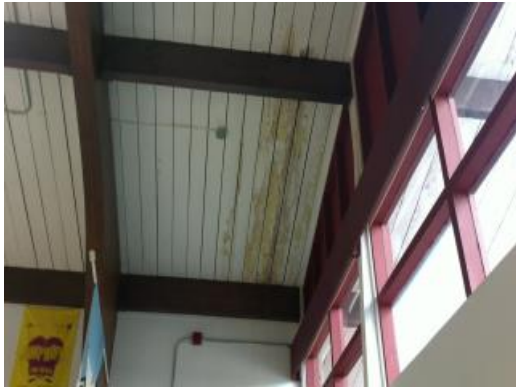
Stained Wood Decking

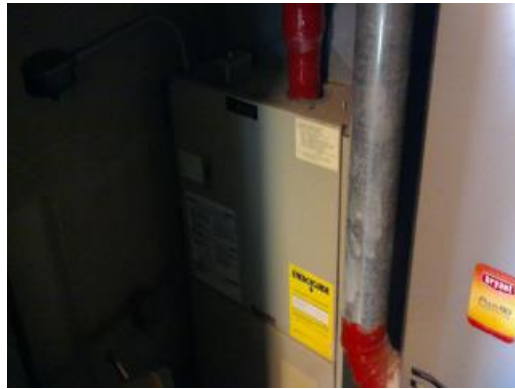
Corroding Furnace

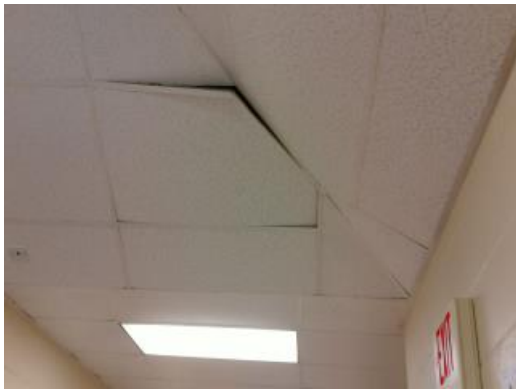
Ceiling Tile Falling Out Of Grid

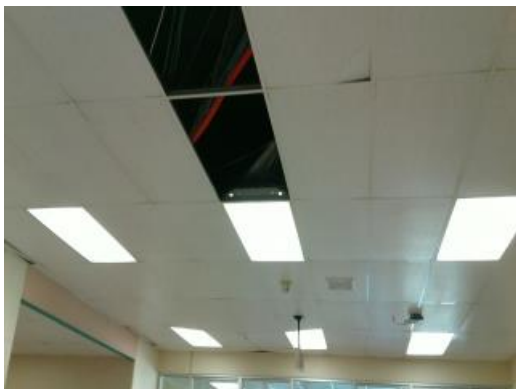
Missing Or Stained Ceiling Tiles

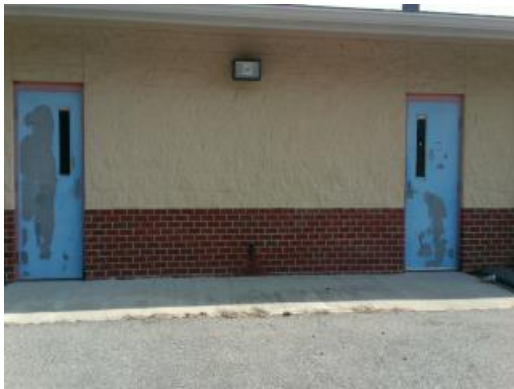
Typical Worn Metal Exterior Doors

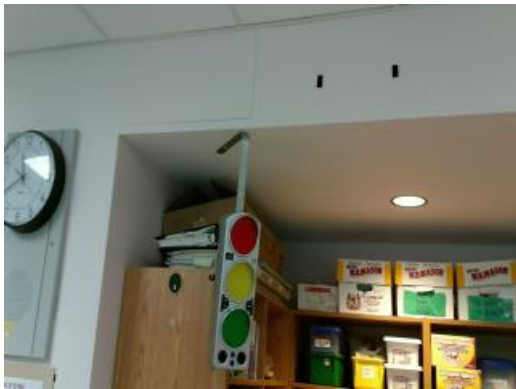
Cracks In Painted Walls

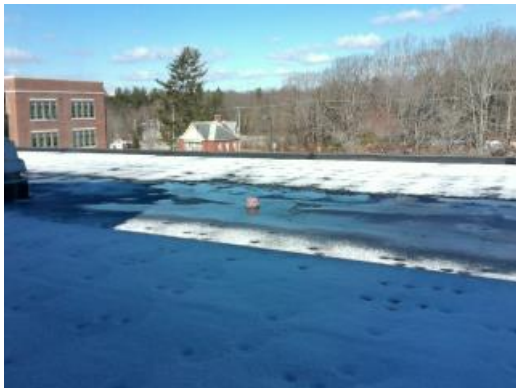
Main Building - Roof General Condition

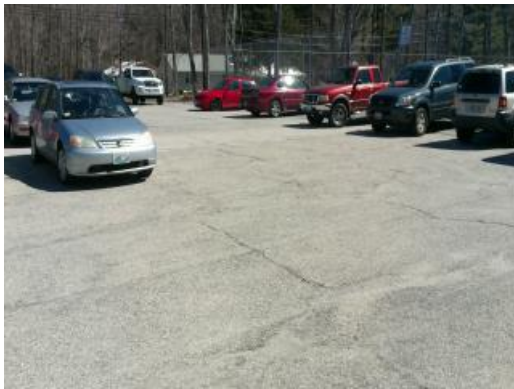
Site - Weathered Asphalt Paving

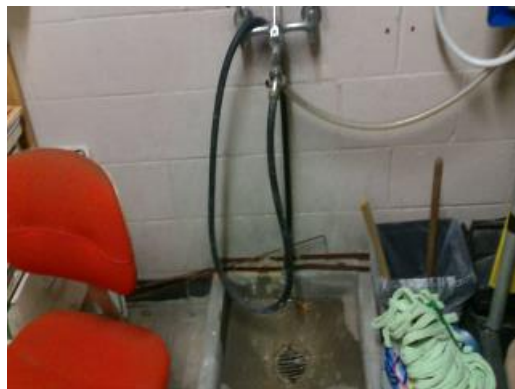
Main Building - Aged Mop Sink

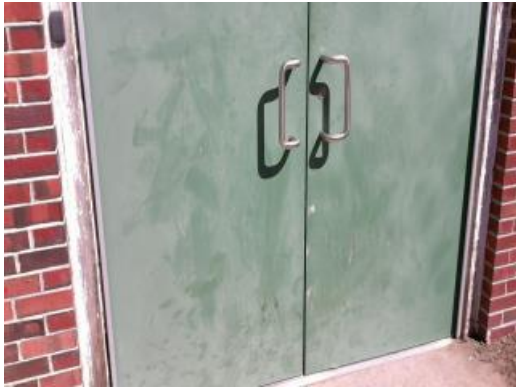
Main Building - Faded Metal Exterior Doors

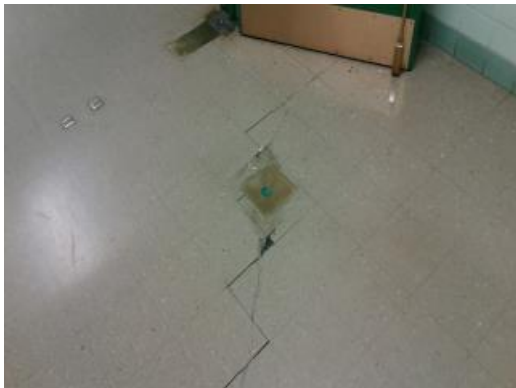
Main Building - Cracked And Separating 9x9 Tile

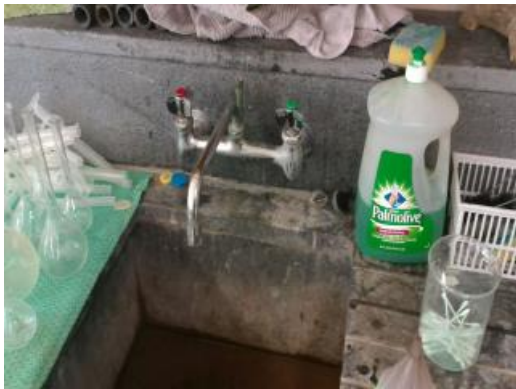
Main Building - Corroded Classroom Sink

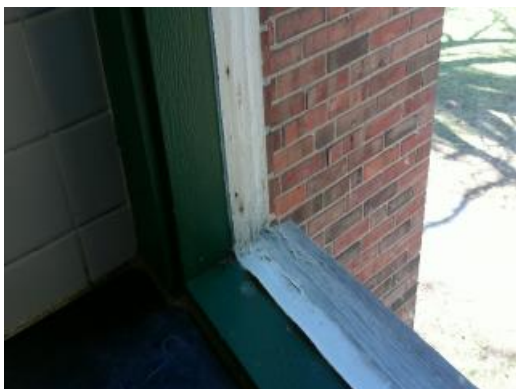
Main Building - Weathered Wood Frame Window

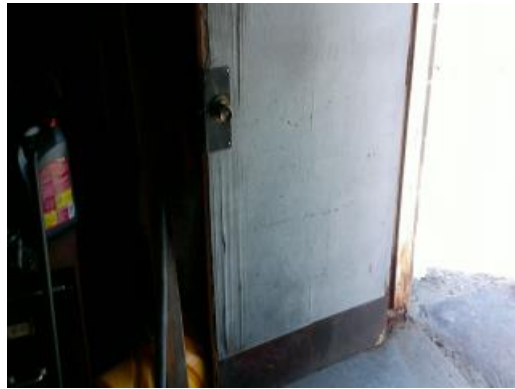
Maintenance Shed - Damaged Exterior Door

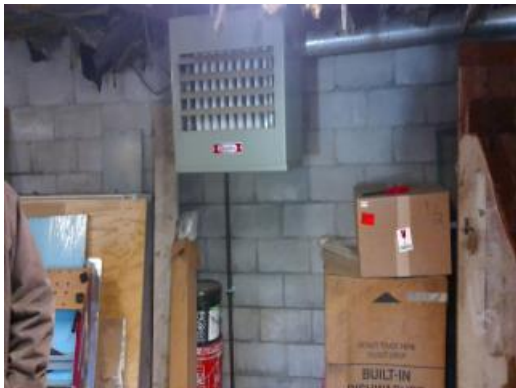
Maintenance Shed - Non-Functional Unit Heater

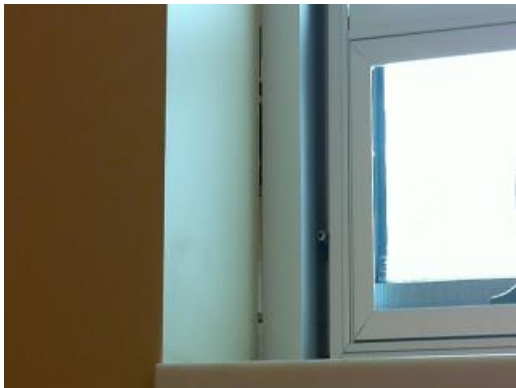
Sealant Failing At Window

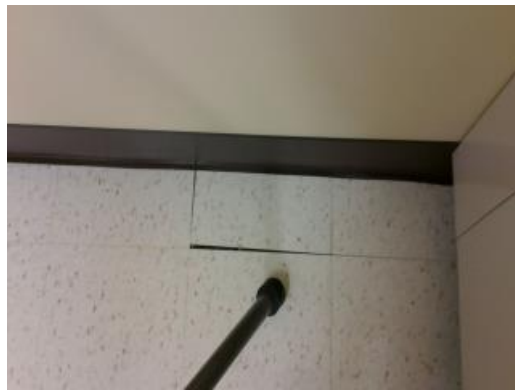
Separating Vinyl Tiles

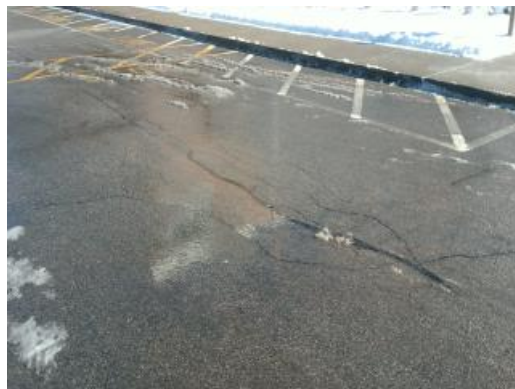
Cracking Asphalt At Main Drain

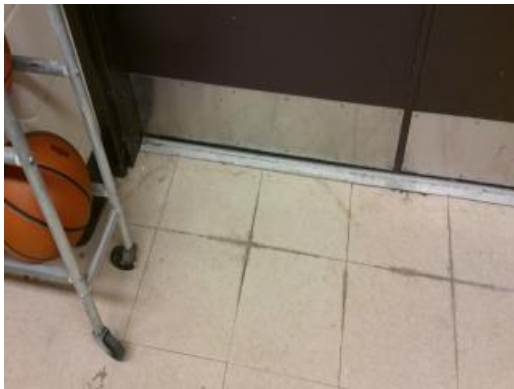
Worn And Stained VCT

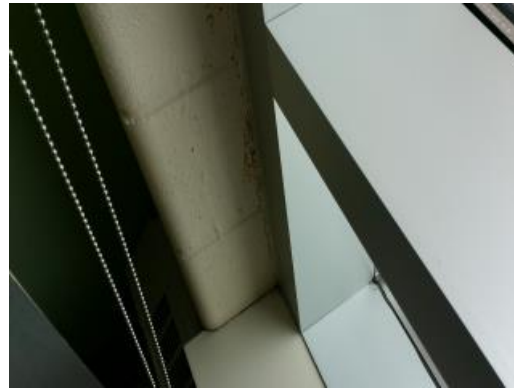
Failed Sealant Allowing Leaks

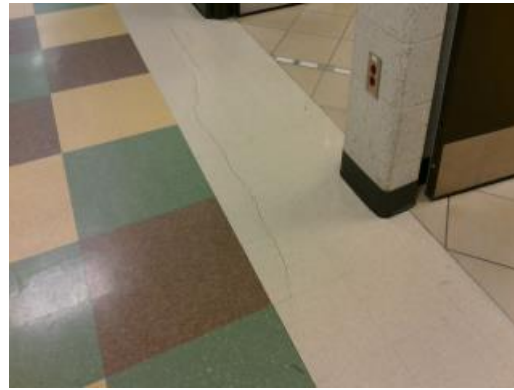
Cracked VCT Floor

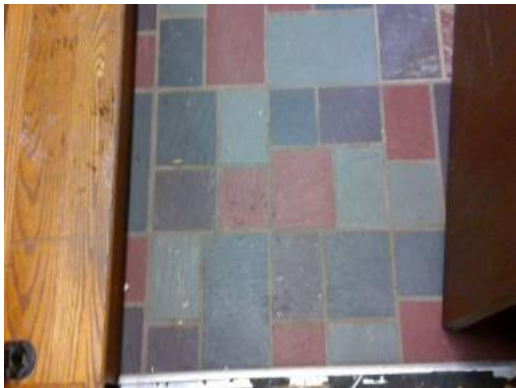
Worn Vinyl Tile
