Facility Condition Assessment

Dr. Harry L. Halliwell Memorial School | *October 2016*

Address: 358 Victory Highway, Slatersville, RI 02876

Report Generated: October 06, 2016

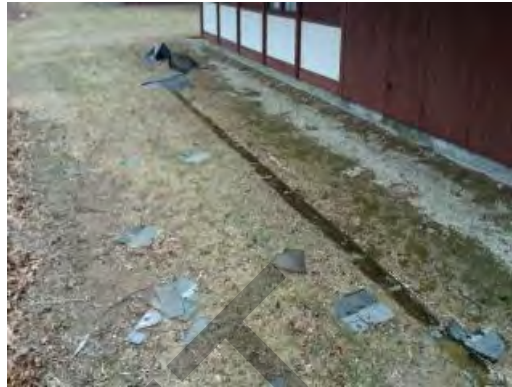
Displaced Roof Shingles

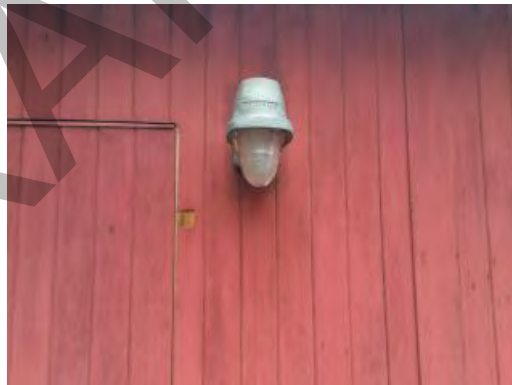
Building Mounted Light

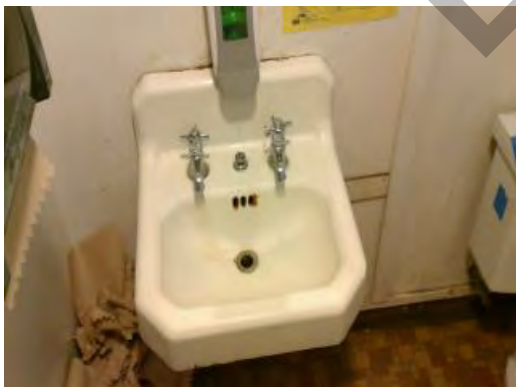
Typical Lavatory Fixture

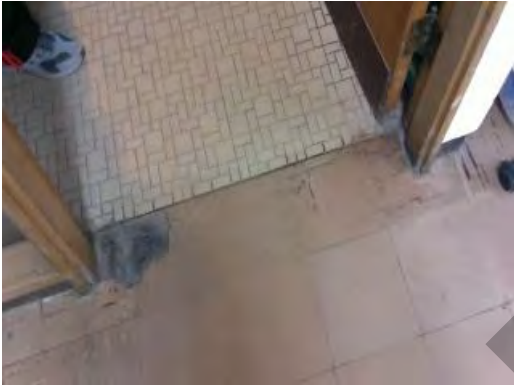
Typical Worn VCT

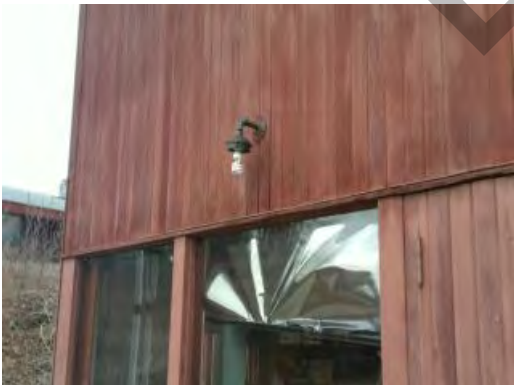
Building Mounted Light

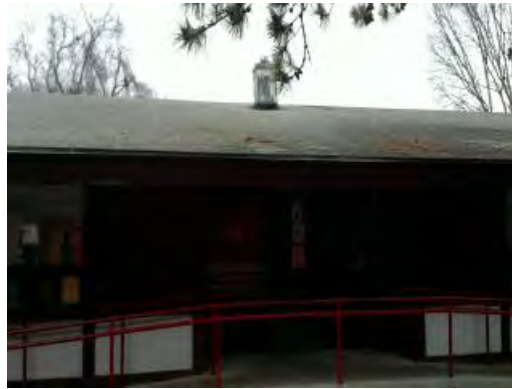
Shingles Missing From Building 2 Roof

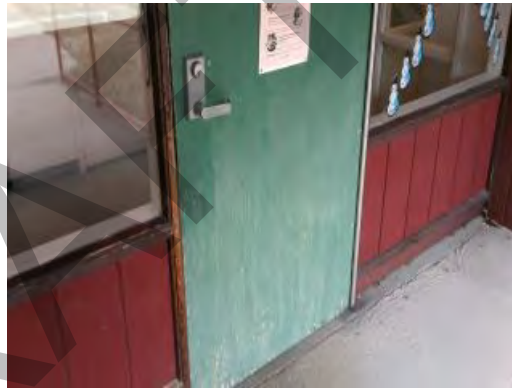
Faded Exterior Door

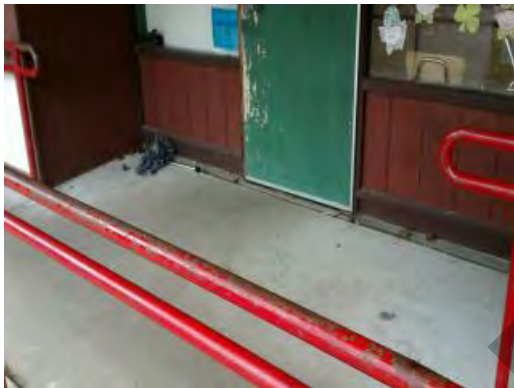
Chipped And Faded Exterior Door

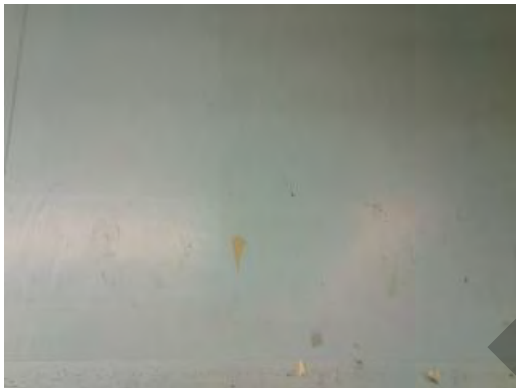
Chipped And Faded Interior Walls

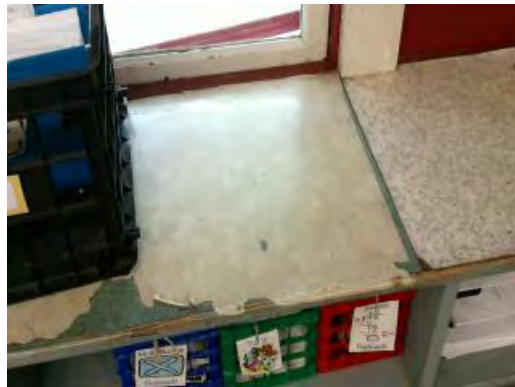
Chipped And Worn Cabinetry

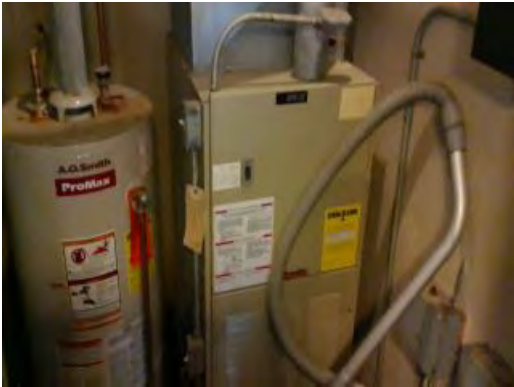
Furnace And Water Heater

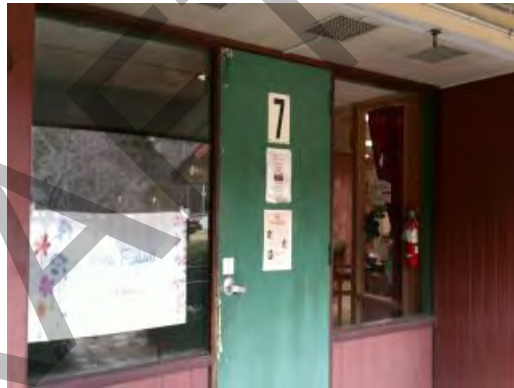
Faded Exterior Door

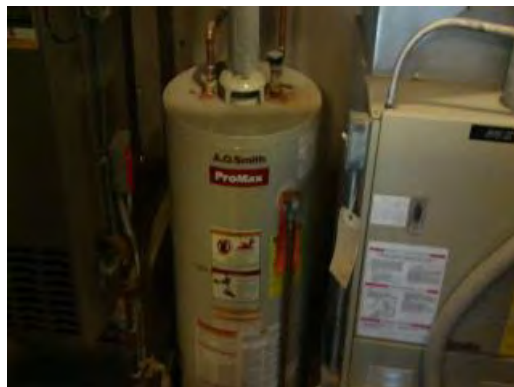
Rusted Water Heater

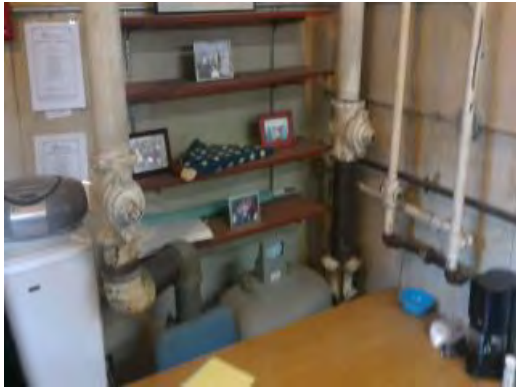
Gas Service Valve

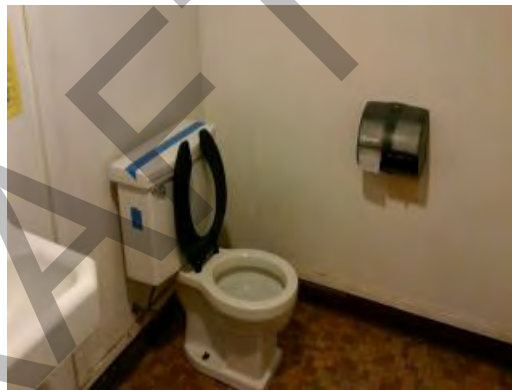
Typical Student Restroom

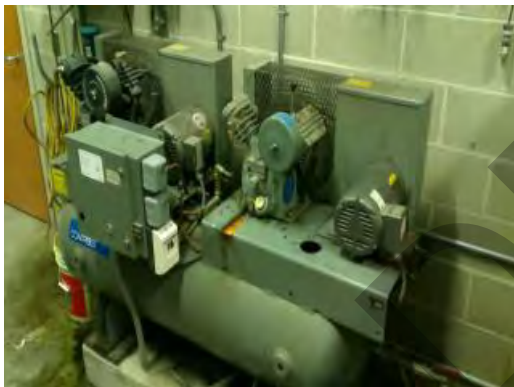
Deficiency	Category	Qty	UoM	Priority	Repair Cost	ID
The Make Up Air Equipment Requires Replacement	Capital Renewal	2	Ea.	3	\$31,585	1477
Existing Controls Are Inadequate And Should Be Replaced With DDC Controls Note: Pneumatics system is leaking.	Capital Renewal	75,000	SF	4	\$503,191	1872
Sub Total for System		2	items		\$534,776

Pneumatics System Leaking

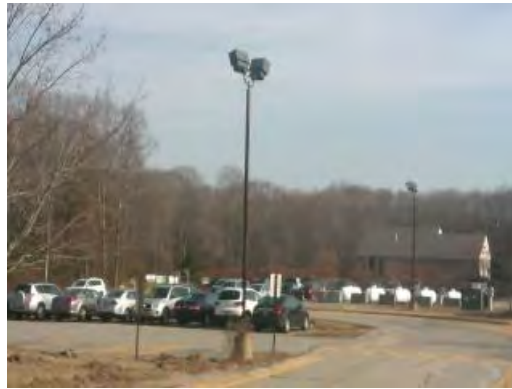
Deficiency	Category	Qty	UoM	Priority	Repair Cost	ID
The Pole Lighting Requires Replacement Note: Pole and units rusted.	Capital Renewal	17	Ea.	3	\$130,607	1522
Sub Total for System		1	Items		\$130,607	
Sub Total for School and Site Level		11	Items		\$2,310,739

Rusted Pole Mounted Lights

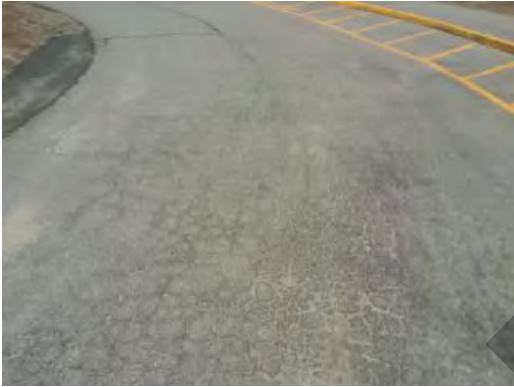
Deficiency	Category	Qty	UoM	Priority	Repair Cost	ID
Asphalt Paving Requires Replacement Note: Cracking pavement	Capital Renewal	116	CAR	3	\$381,204	1530
Asphalt Paving Requires Replacement Note: Cracking, splitting, and failing.	Capital Renewal	146	CAR	3	\$479,791	1544
Concrete Walks Require Replacement Note: Cracked and broken.	Capital Renewal	5,200	SF	3	\$105,570	1886
Fencing Requires Replacement (4' Chain Link Fence) Note: Fence falling and requires replacement.	Capital Renewal	230	LF	3	\$14,769	1543
Install New Paving Note: Add second entrance from Mowry Farms Lane	Traffic	15,900	SF	3	\$330,314	4459
Asphalt Paving Requires Replacement Note: Paved play areas splitting and cracking.	Capital Renewal	95	CAR	4	\$312,193	1531
Backstops Require Replacement Note: Backstops Require Replacement	Educational Adequacy	1	Ea.	4	\$28,674	28526
Exterior Basketball Goals Require Replacement Note: Basketball goals are damaged.	Capital Renewal	2	Ea.	4	\$15,260	1542

Cracking Asphalt Paving

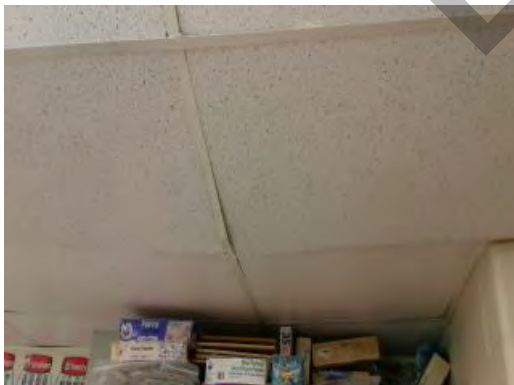
Bent Ceiling Grid

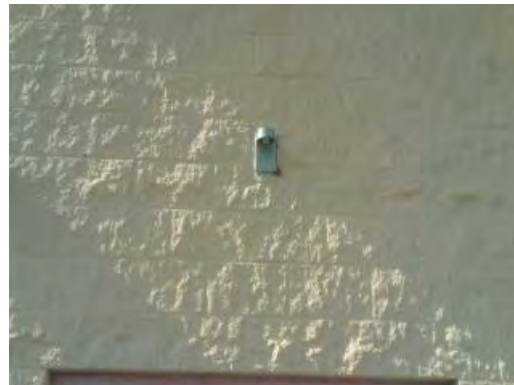
Broken Building Mounted Light

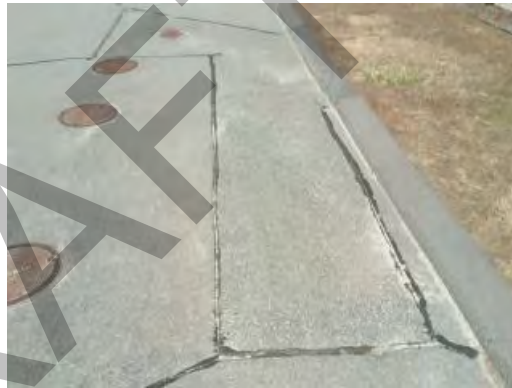
Damaged Play Area Asphalt

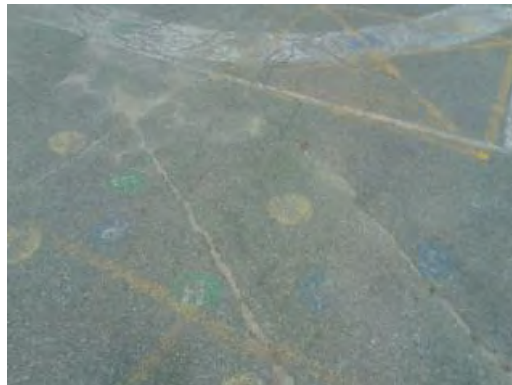
Cracked, Worn Play Area Asphalt

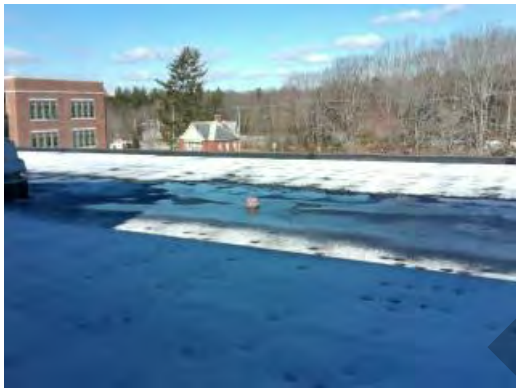
Main Building - Roof General Condition

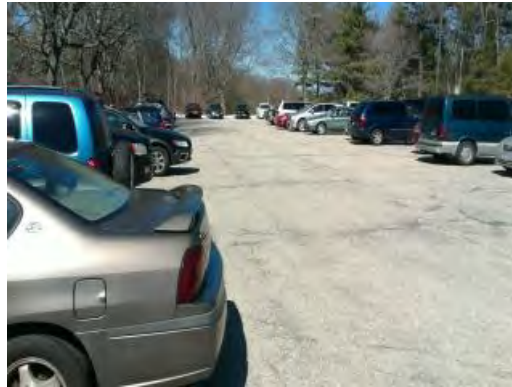
Site - Cracked And Worn Asphalt Parking Lot

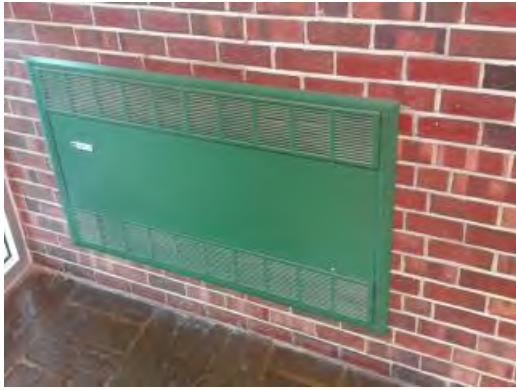
Main Building - Original Hallway Unit Heater

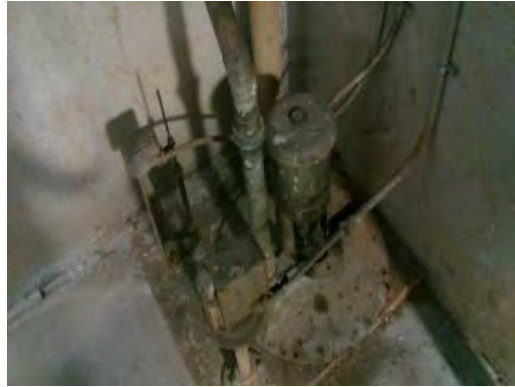
Main Building - Inoperable Sump Pump

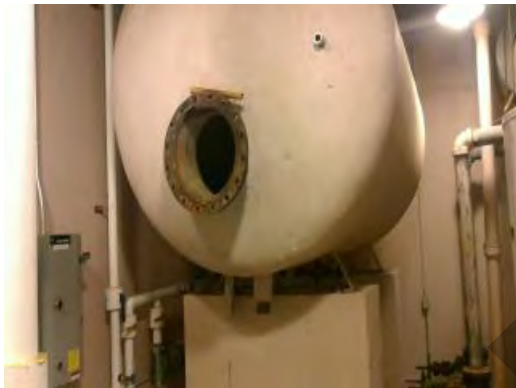
Main Building - Abandoned Storage Tank

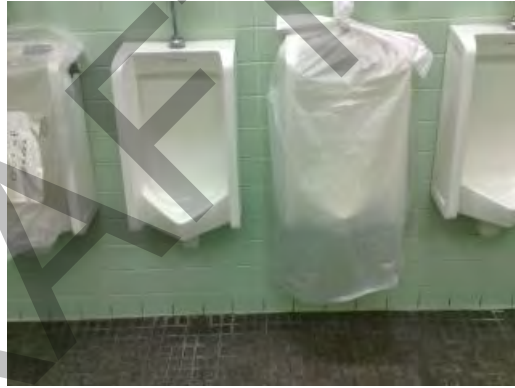
Main Building - Urinals Out Of Service

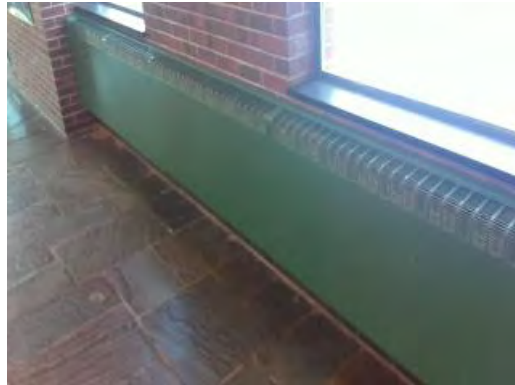
Main Building - Original Radiator

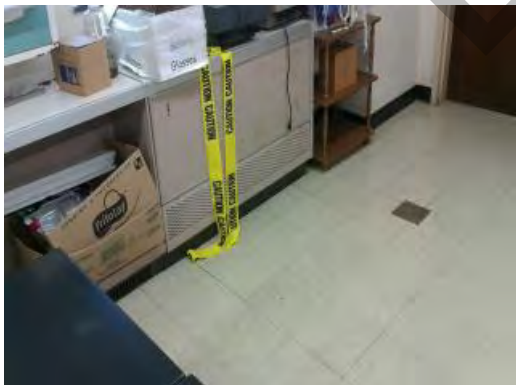
Main Building - Failed Classroom Unit Heater

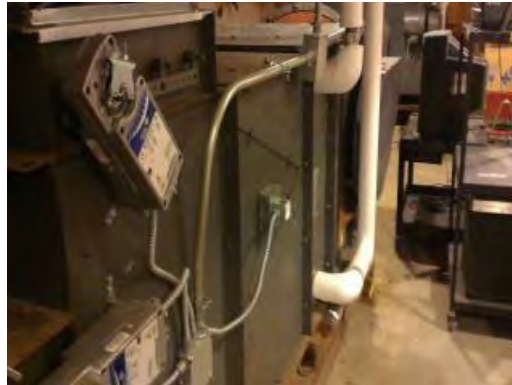
Main Building - Original AHU

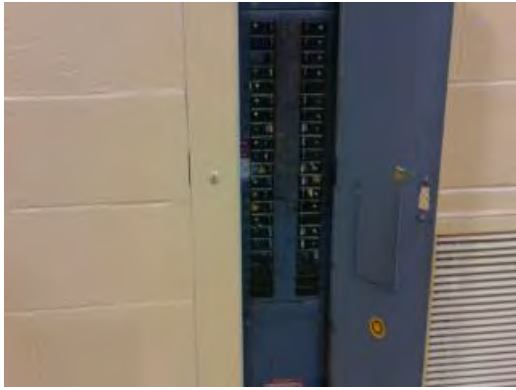
Main Building - Typical Aged Panelboard

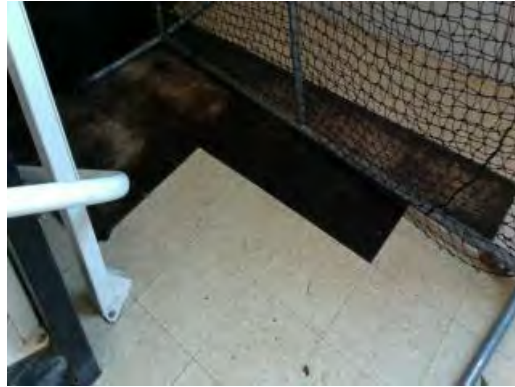
Main Building - Cracked And Missing VCT

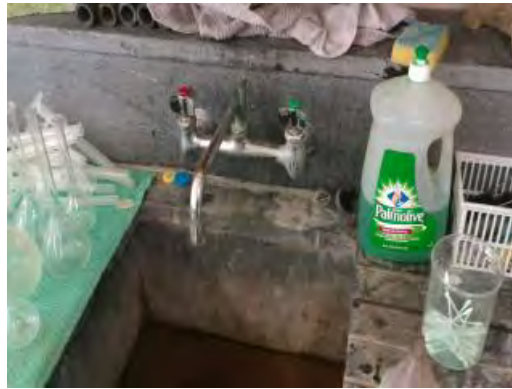
Main Building - Corroded Classroom Sink

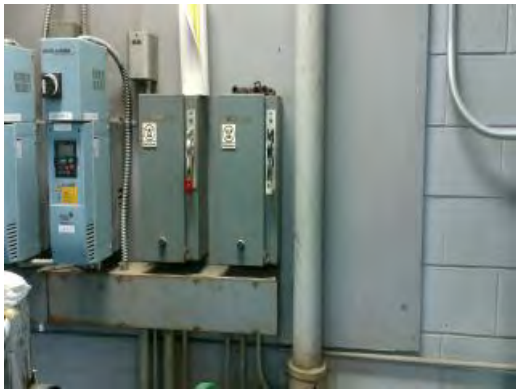
Main Building - Abandoned Electrical Disconnects

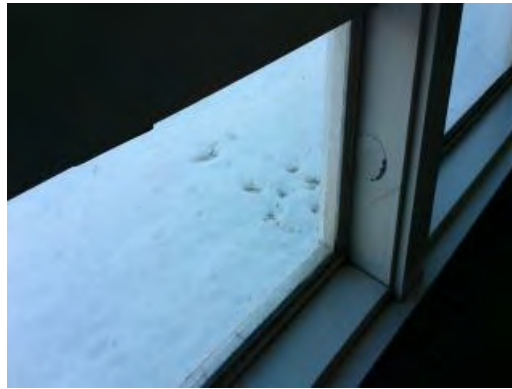
Main Building - Typical Single-Pane Window

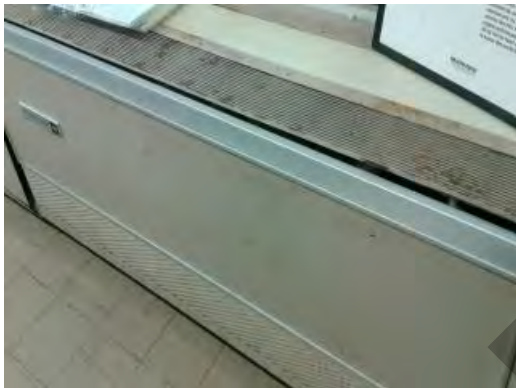
Main Building - Aged Heating Unit Ventilator

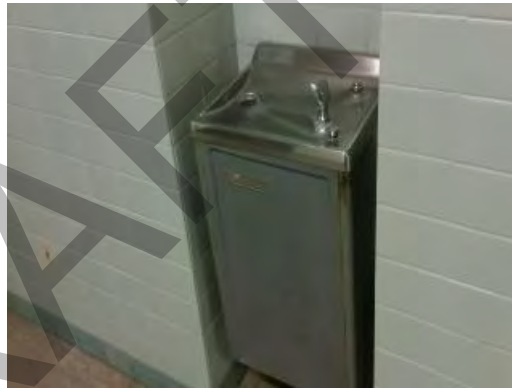
Main Building - Non-Functional Drinking Fountain

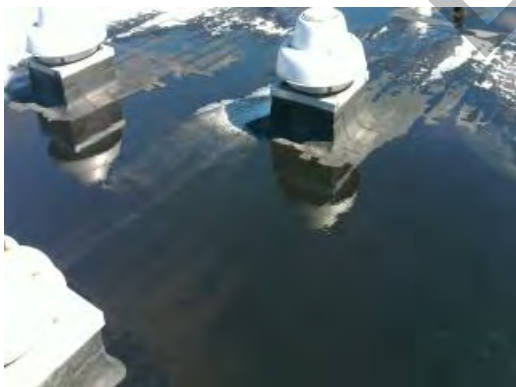
Main Building - Typical Exhaust Fans

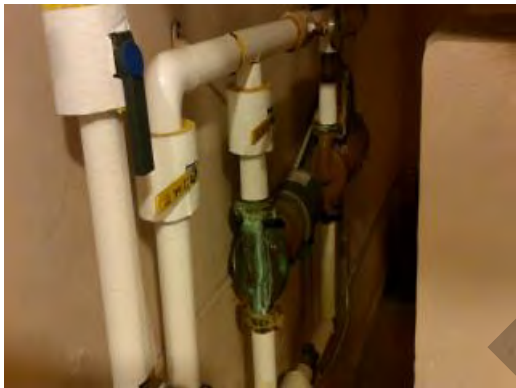
Main Building - Abandoned Circulators

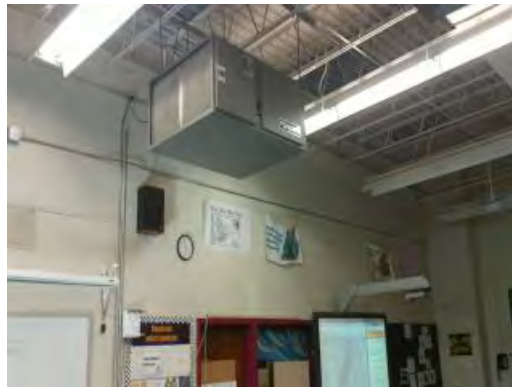
Main Building - Poorly Functioning Unit Heater

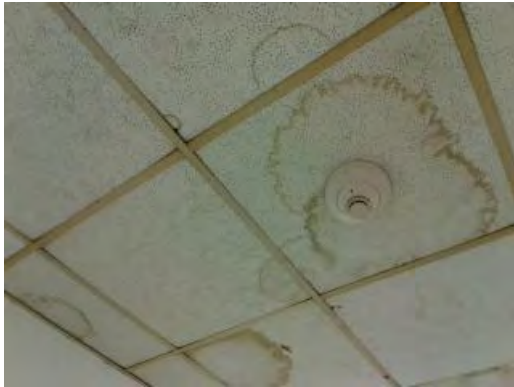
Main Building - Stained Ceiling Grid And Tiles

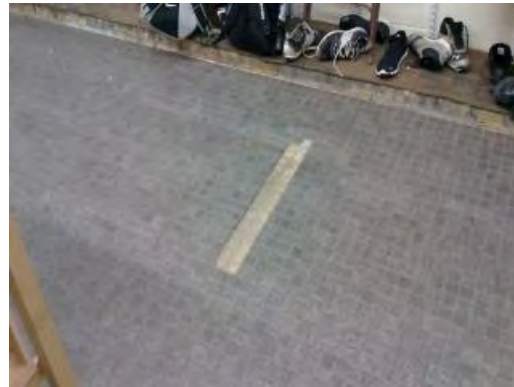
Main Building - Missing Ceramic Tiles

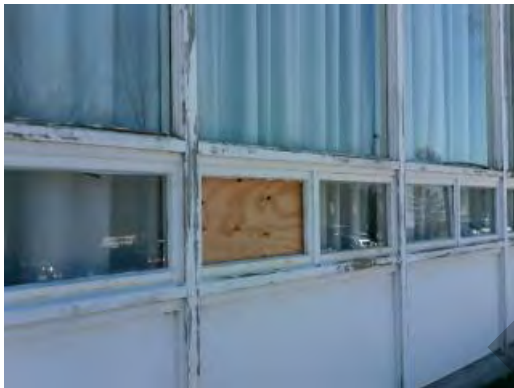
Main Building - Windows With Missing Pane

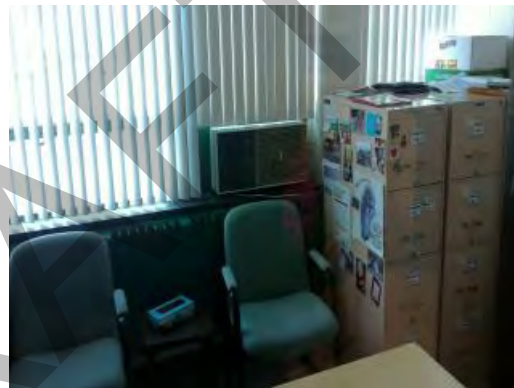
Main Building - Non-Functional Window Unit

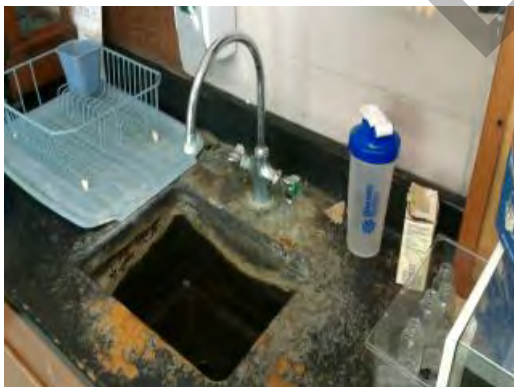
Main Building - Corroded Classroom Sink

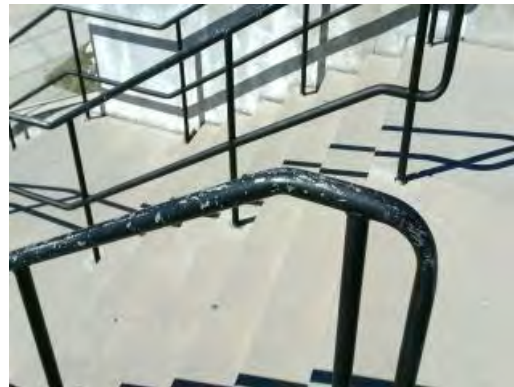
Main Building - Chipped Paint On Handrail

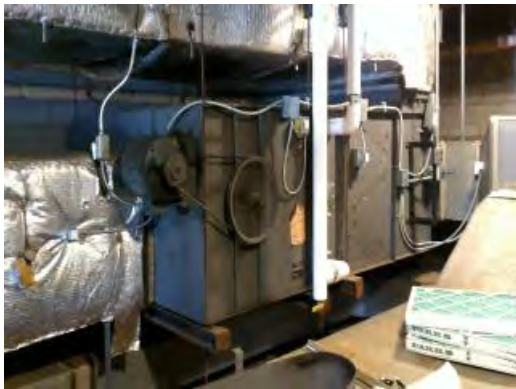
Main Building - Original AHU

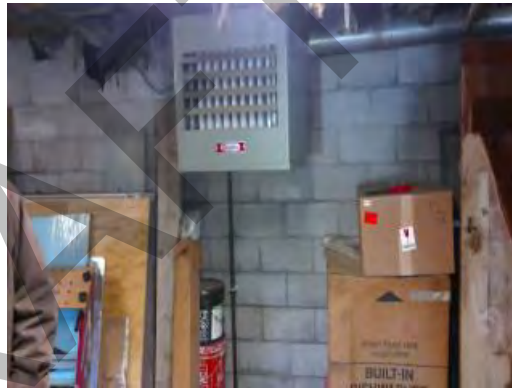
Maintenance Shed - Non-Functional Unit Heater

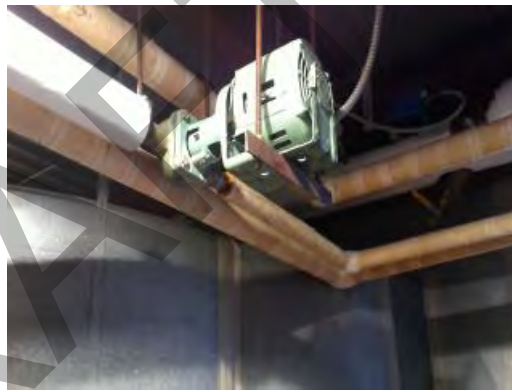
Main Building - Original Pump

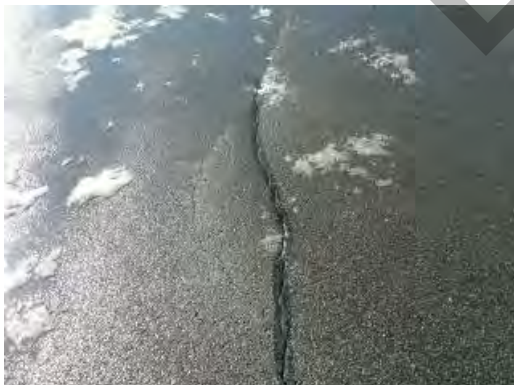
Cracking At Asphalt Joint

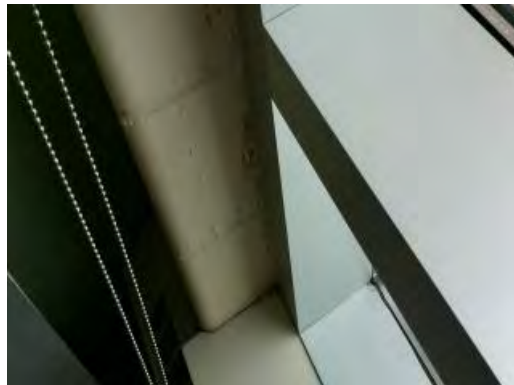
Failed Sealant Allowing Leaks

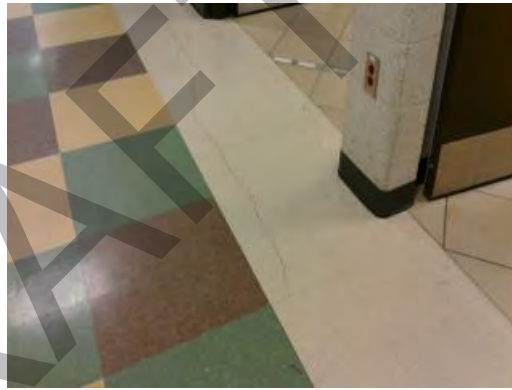
Cracked VCT Floor

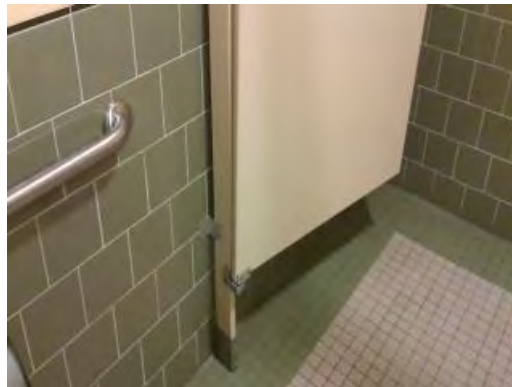
Crooked Toilet Partition

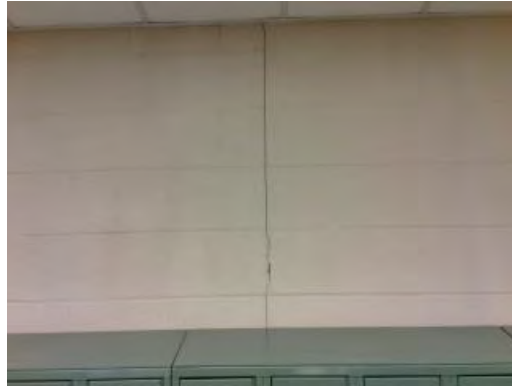
Cracked CMU Wall

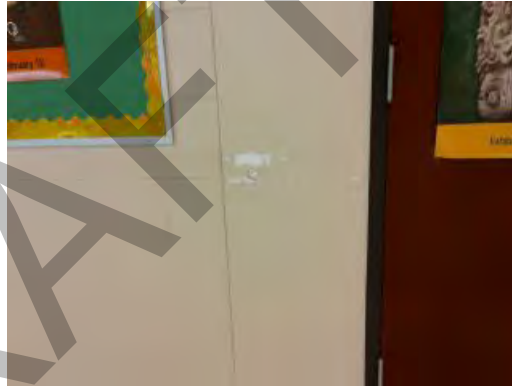
Typical Chipped Paint

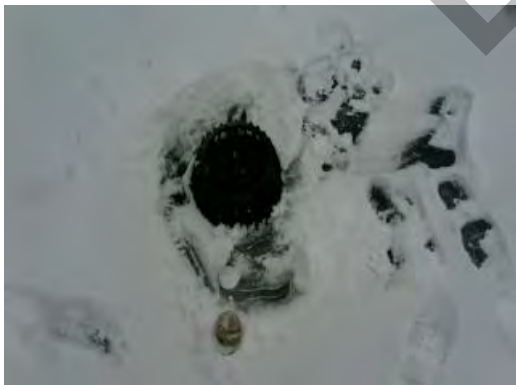
Blocked Roof Drain
