# North Smithfield

# Facility Condition Assessment

Dr. Harry L. Halliwell Memorial School, located at 358 Victory Highway in Slatersville, Rhode Island, was built in 1957. It comprises 41,175 gross square feet. Each school across the district was visited three times during the Facility Condition Assessments by three teams of specialists in the spring/summer of 2016.

North Smithfield - Dr. Harry L. Halliwell Memorial School

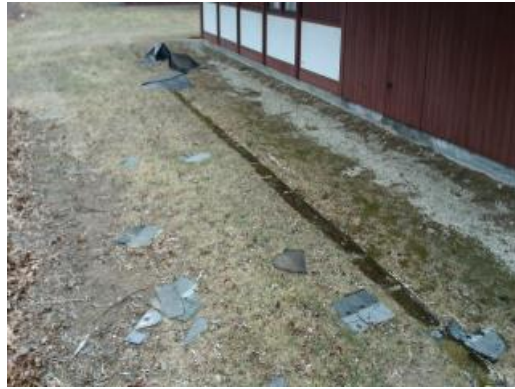
Displaced Roof Shingles

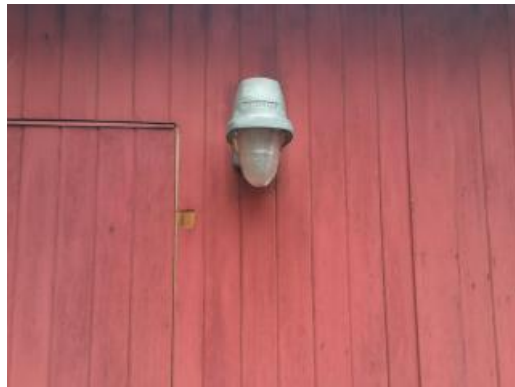
Building Mounted Light

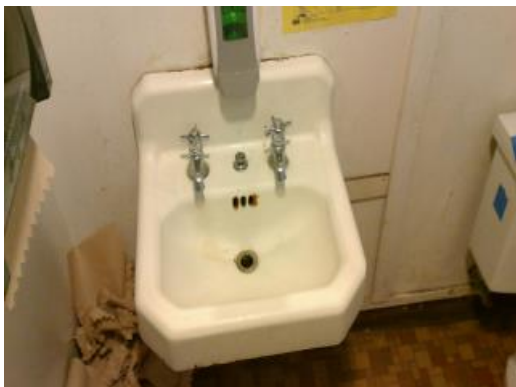
Typical Lavatory Fixture

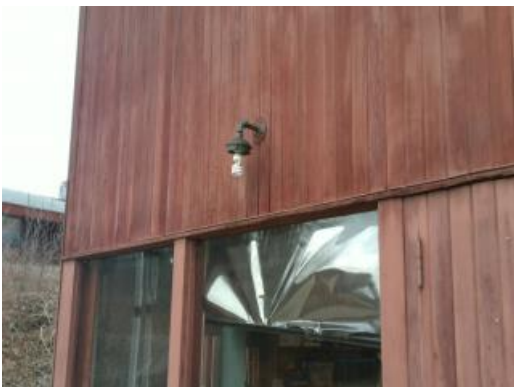
Building Mounted Light

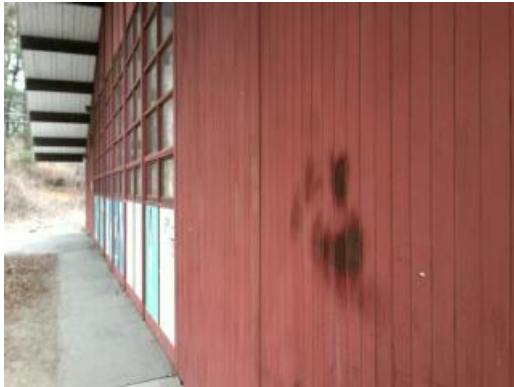
Stained Wood Exterior

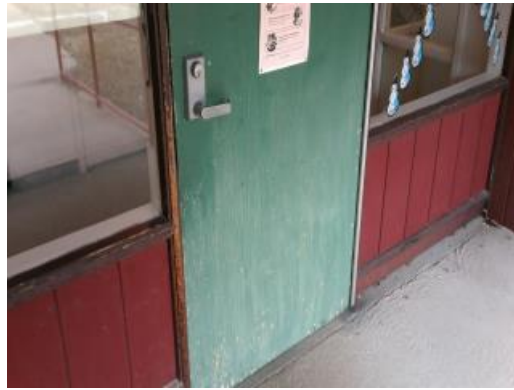
Faded Exterior Door

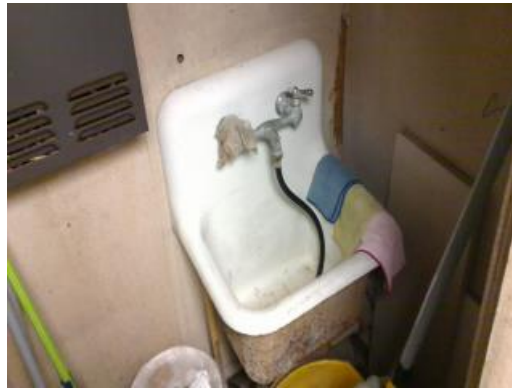
Stained Service Sink

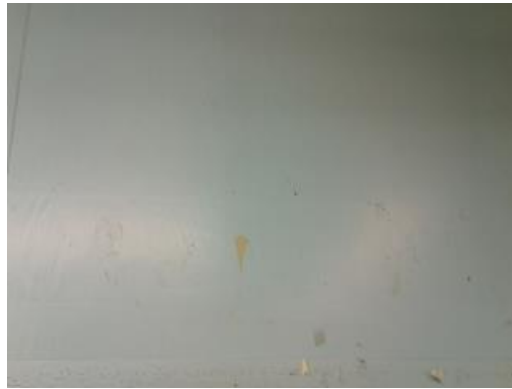
Chipped And Faded Interior Walls

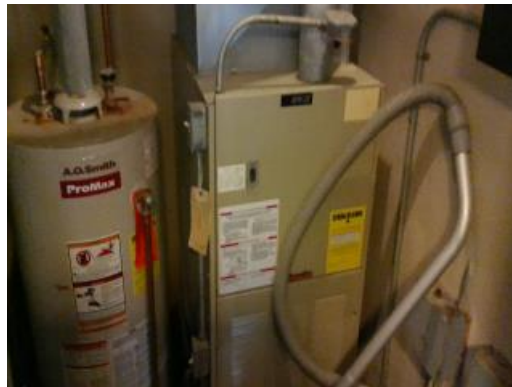
Furnace And Water Heater

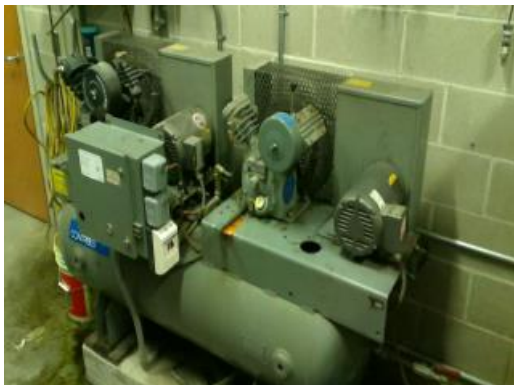
Pneumatics System Leaking

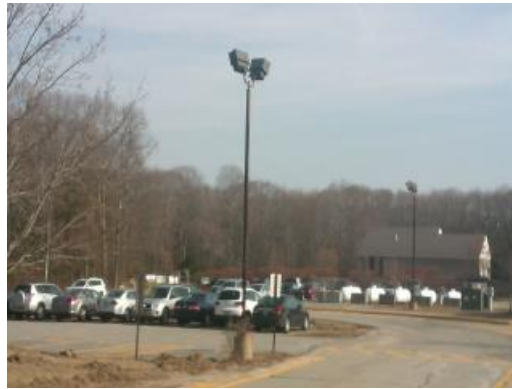
Rusted Pole Mounted Lights

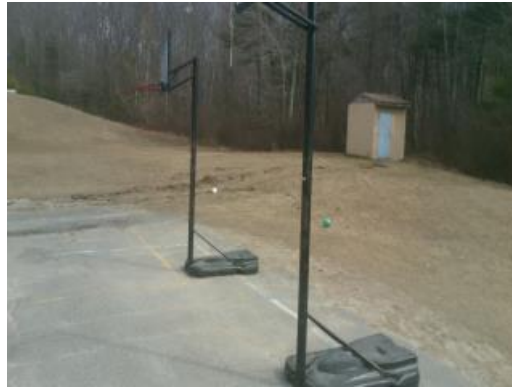
Damaged Basketball Goals

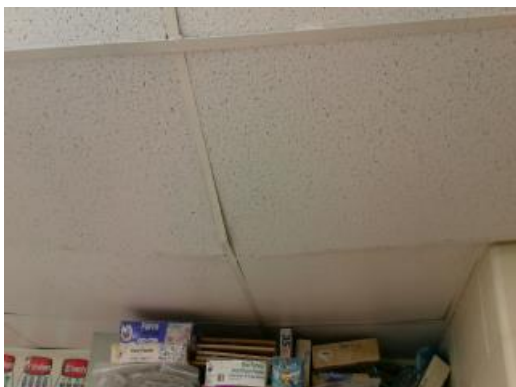
Bent Ceiling Grid

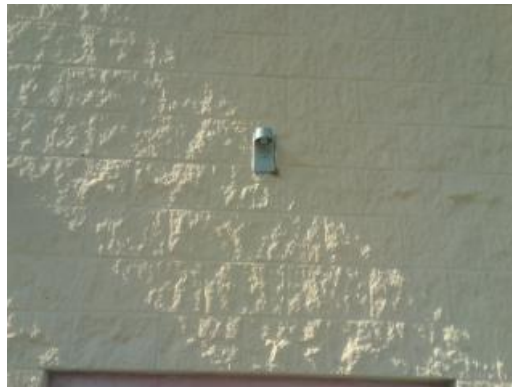
Broken Building Mounted Light

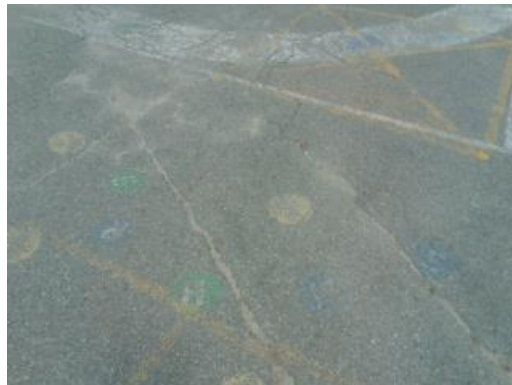
Cracked, Worn Play Area Asphalt

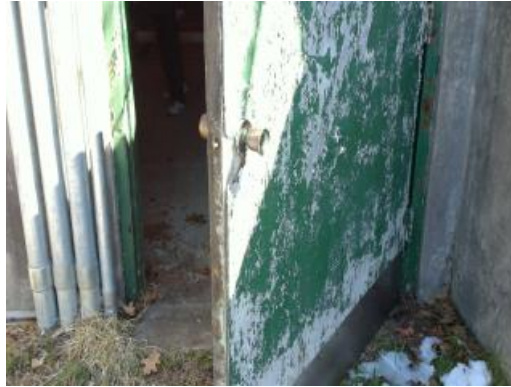
Pump House - Weathered Exterior Door

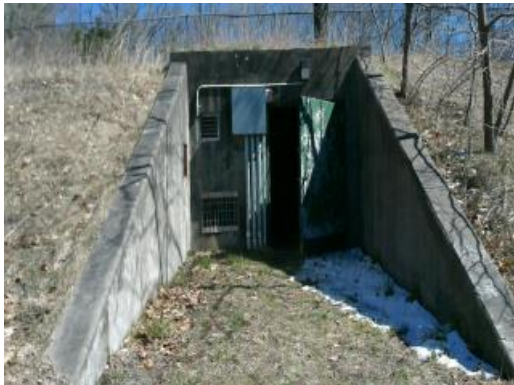
Pump House - Exterior

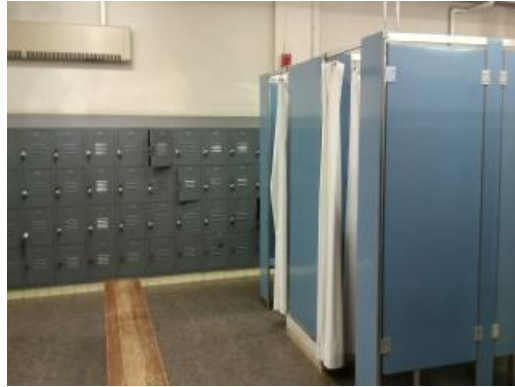
Main Building - Girls Locker Room

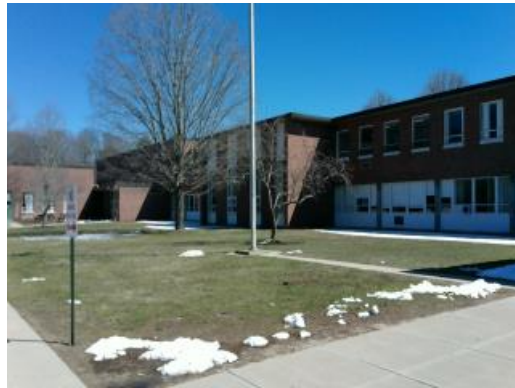
Main Building - Exterior

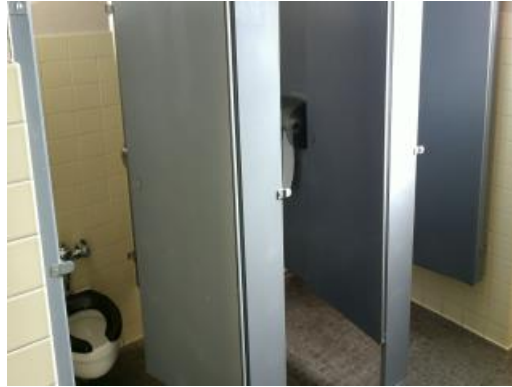
Main Building - Typical Restroom Fixtures And Finishes

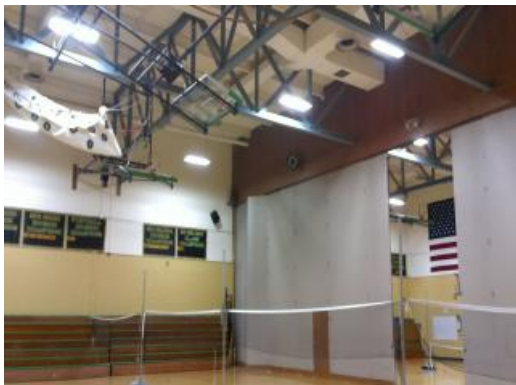
Main Building - Gymnasium

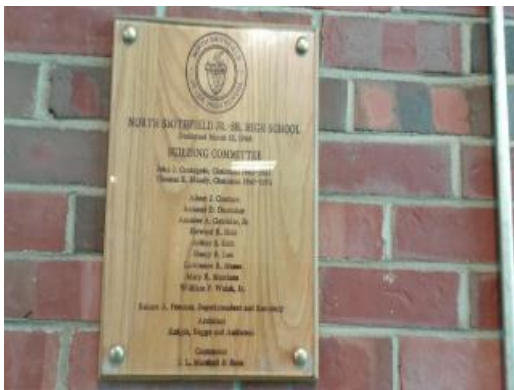
Main Building - Dedication Plaque

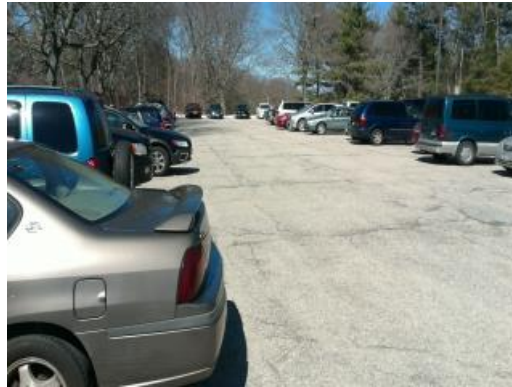
Site - Cracked And Worn Asphalt Parking Lot

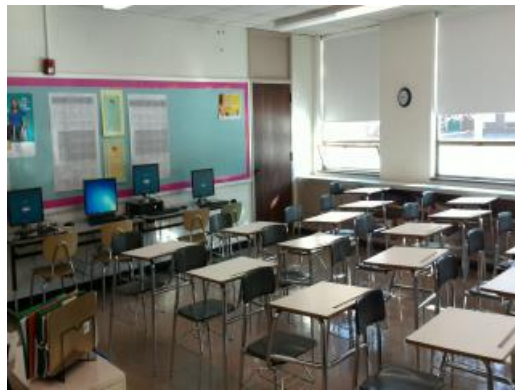
Main Building - Typical Classroom

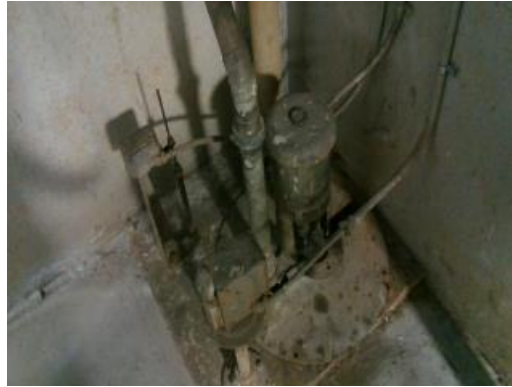
Main Building - Inoperable Sump Pump

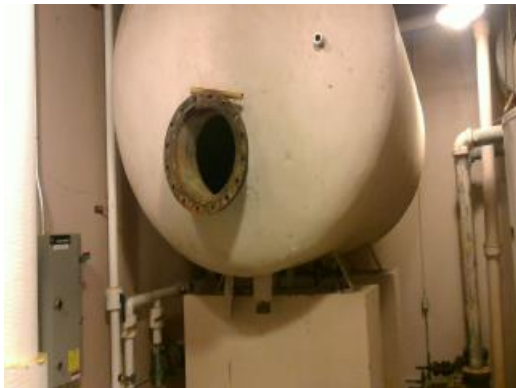
Main Building - Abandoned Storage Tank

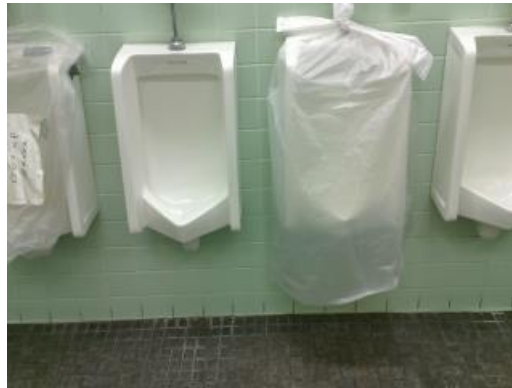
Main Building - Urinals Out Of Service

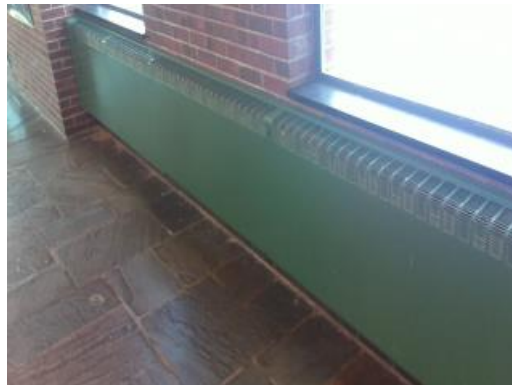
Main Building - Original Radiator

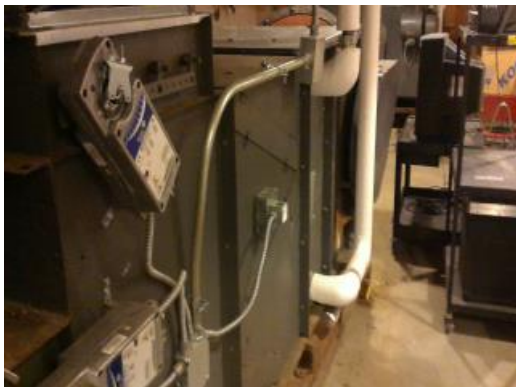
Main Building - Original AHU

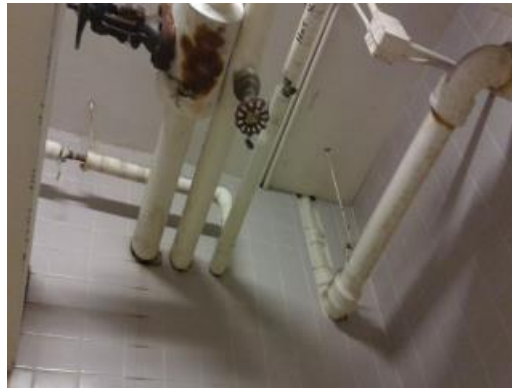
Main Building - Corrosion On Water Piping

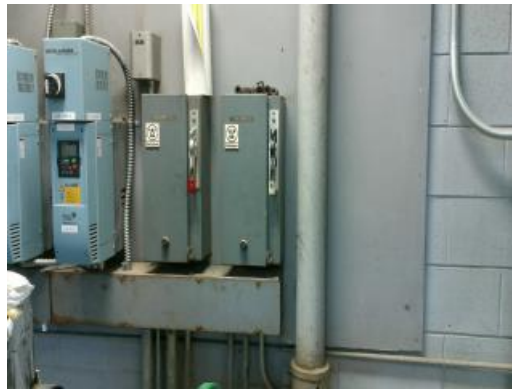
Main Building - Abandoned Electrical Disconnects

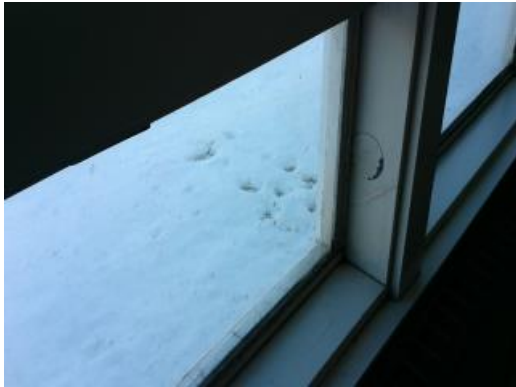
Main Building - Typical Single-Pane Window

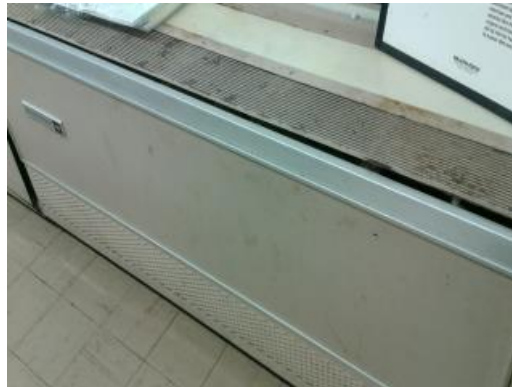
Main Building - Aged Heating Unit Ventilator

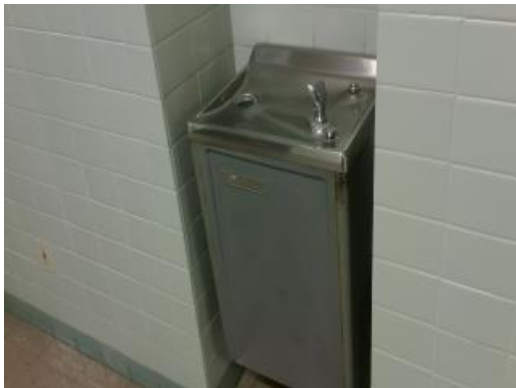
Main Building - Non-Functional Drinking Fountain

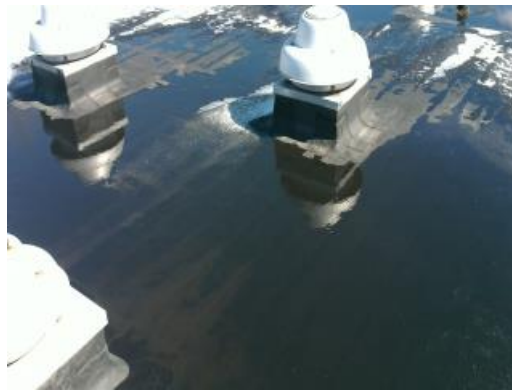
Main Building - Typical Exhaust Fans

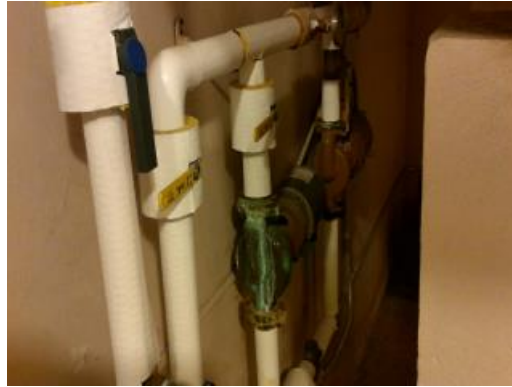
Main Building - Abandoned Circulators

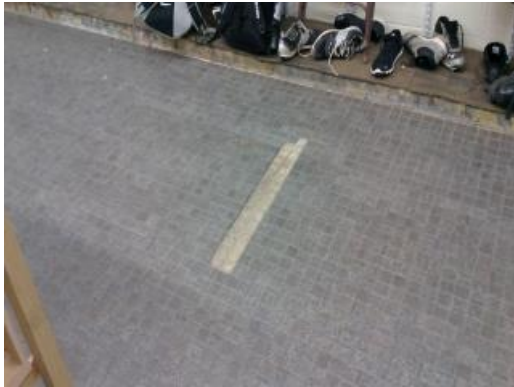
Main Building - Missing Ceramic Tiles

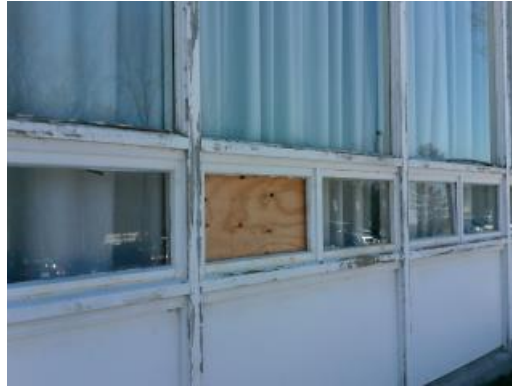
Main Building - Windows With Missing Pane

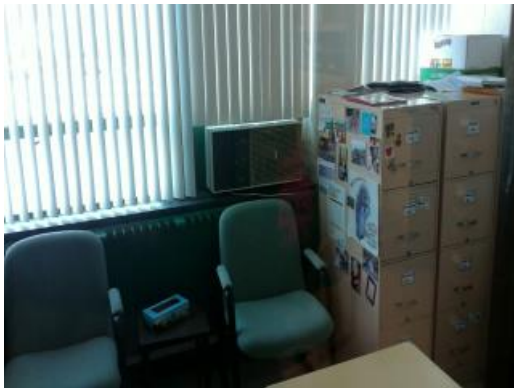
Main Building - Non-Functional Window Unit

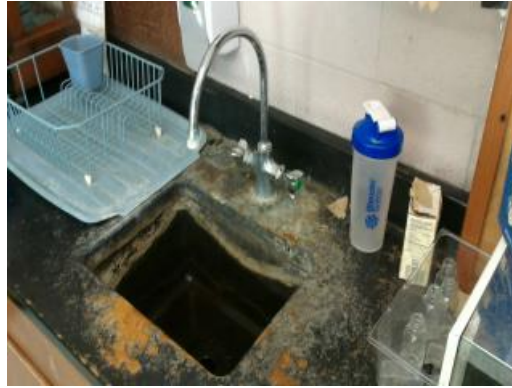
Main Building - Corroded Classroom Sink

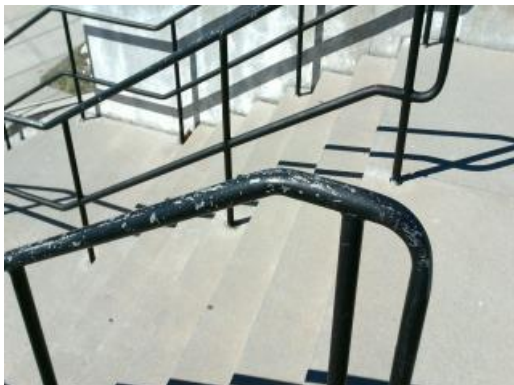
Main Building - Chipped Paint On Handrail

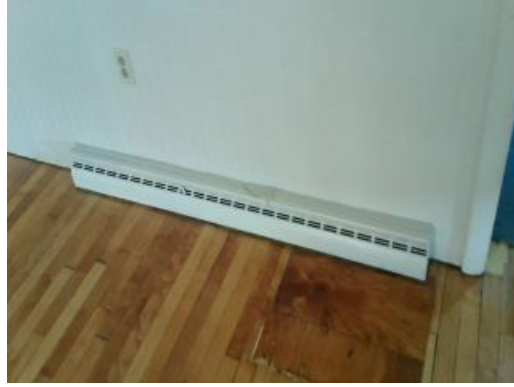
Damaged Baseboard Heater

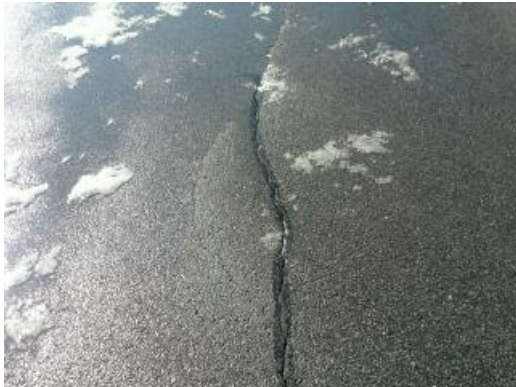
Cracking At Asphalt Joint

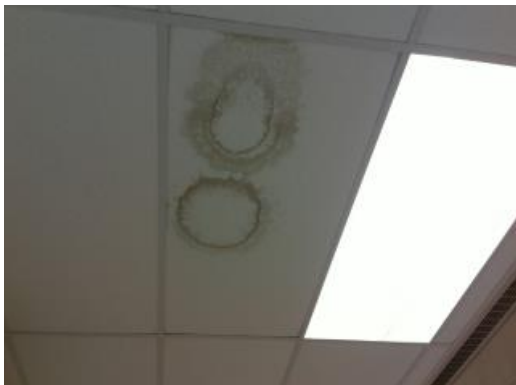
Stained Ceiling Tile

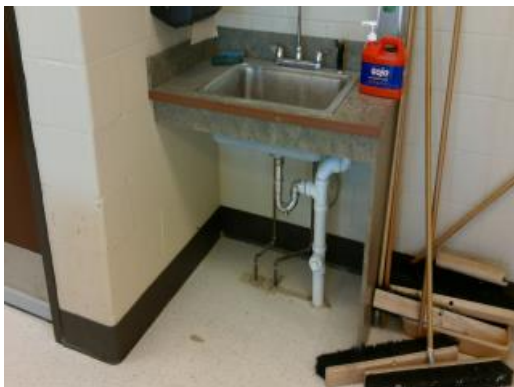
Pipe Missing Insulation

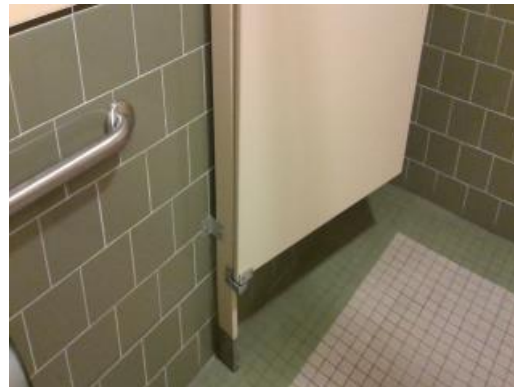
Crooked Toilet Partition

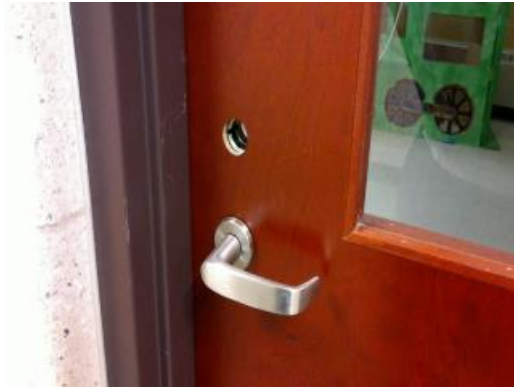
Missing Door Lock

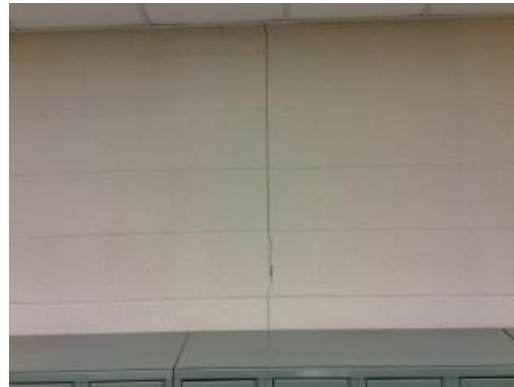
Cracked CMU Wall

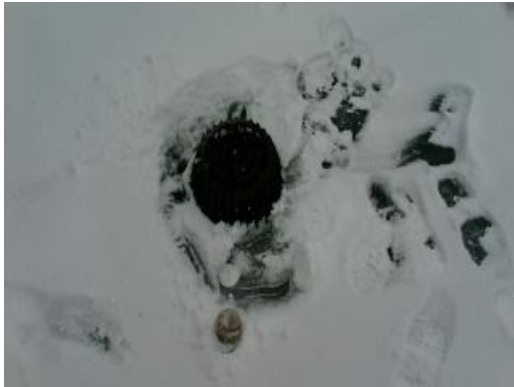
Blocked Roof Drain

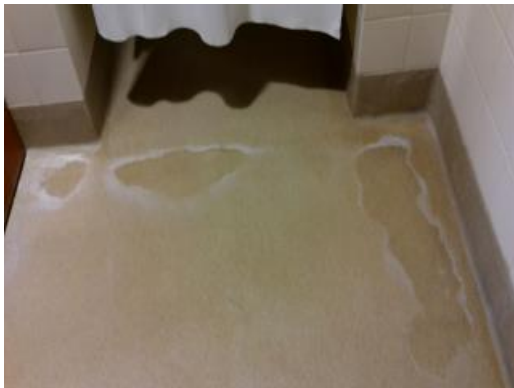
Water Damage Due To Floor Slope At Shower

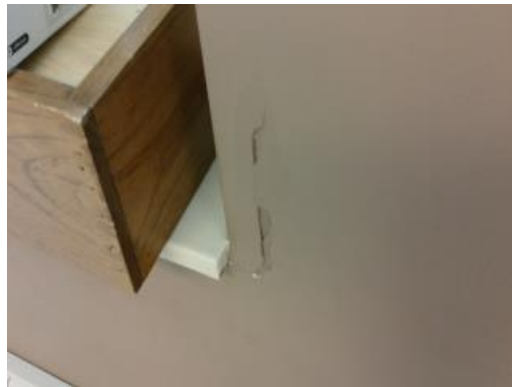
Damaged Gypsum Board Wall
