Facility Condition Assessment

Dr. Harry L. Halliwell Memorial School | *October 2016*

Address: 358 Victory Highway, Slatersville, RI 02876

Report Generated: October 06, 2016

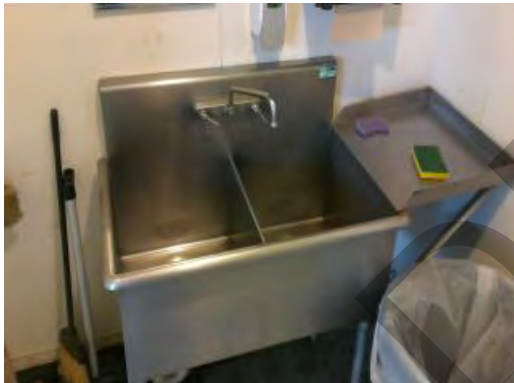
Kitchen Sink

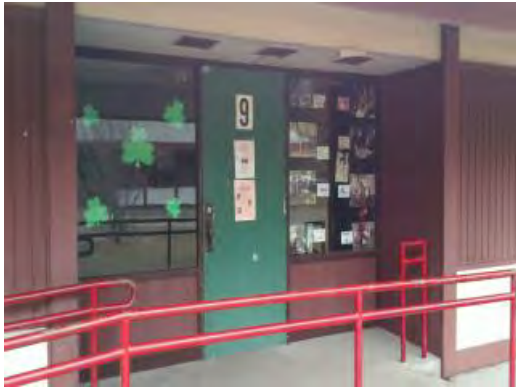
Exterior Door

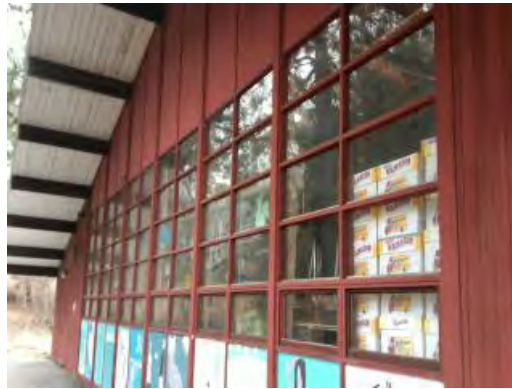
Exterior Windows

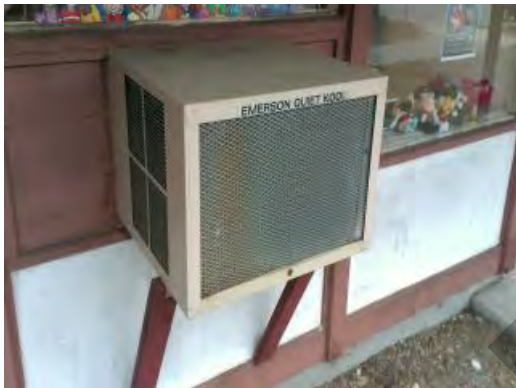
Window Unit

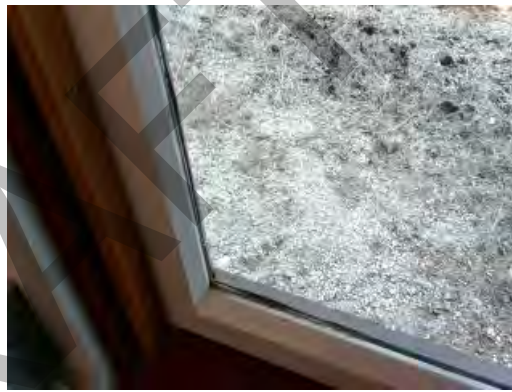
Single Pane Window

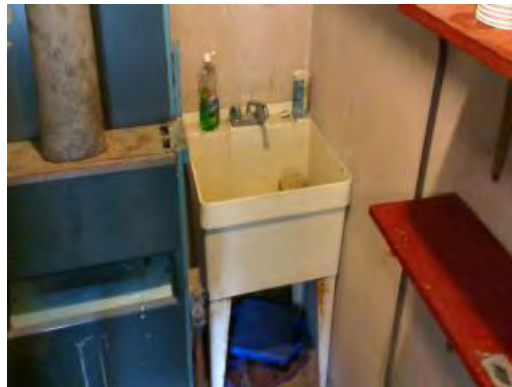
Mop Sink

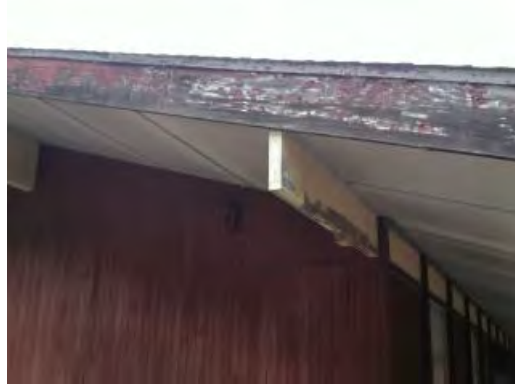
Wood Exterior

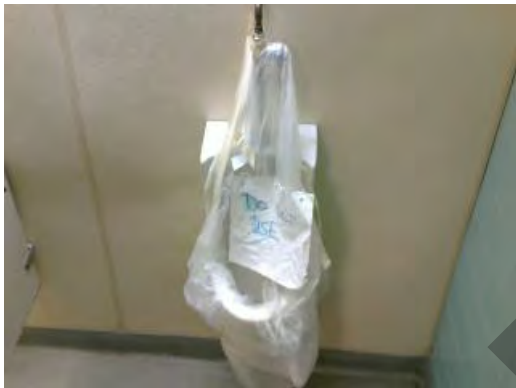
Urinal Out Of Service

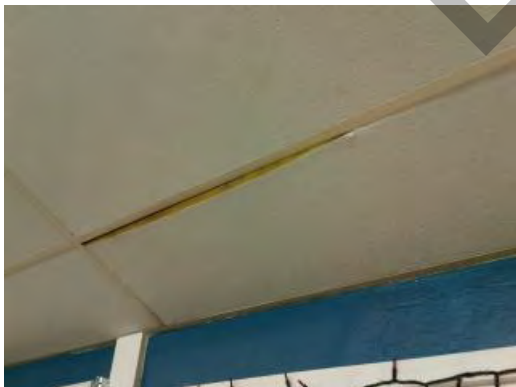
Typical Acoustic Tile

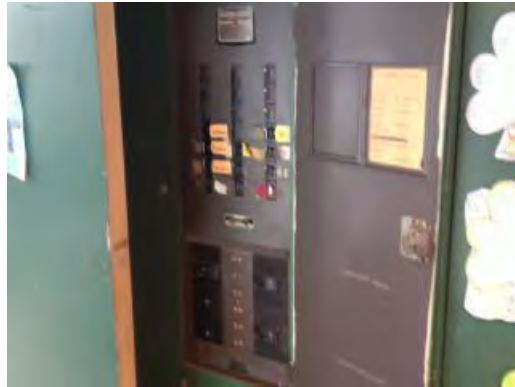
Aged Panelboard

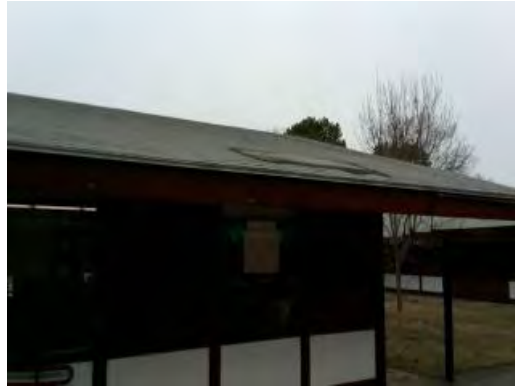
Building 4 Roof

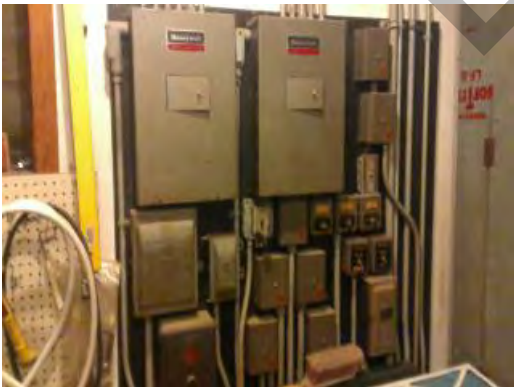
Rudimentary ECS

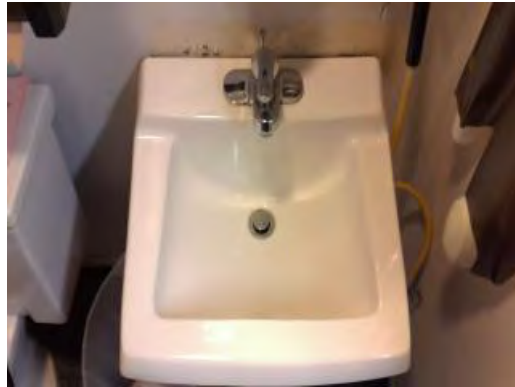
Lavatory

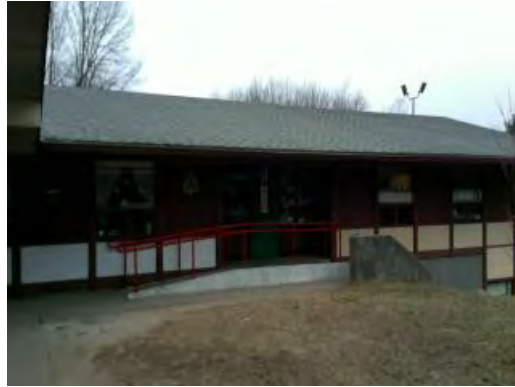
Building 8 Roof

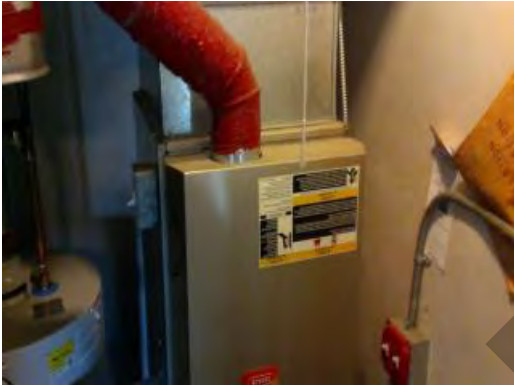
Furnace

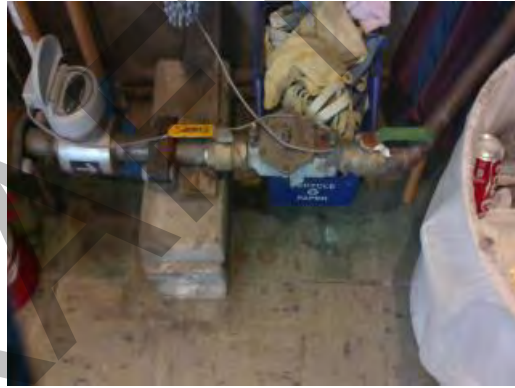
Backflow Preventer

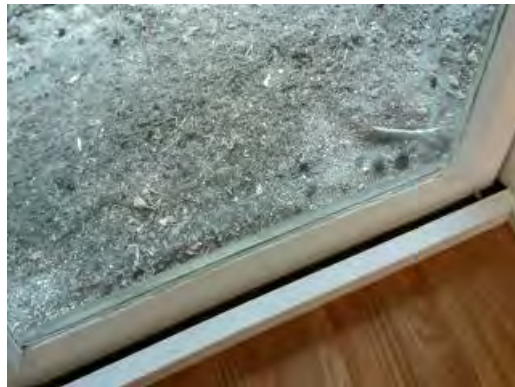
Typical Window

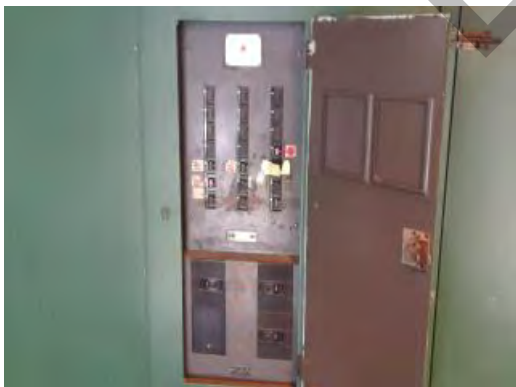
Aged Panelboard

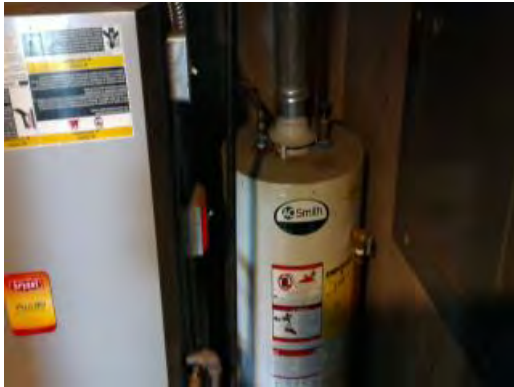
Water Heater

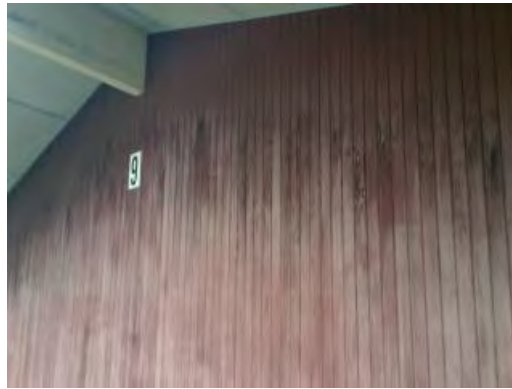
Weathered Wood Exterior

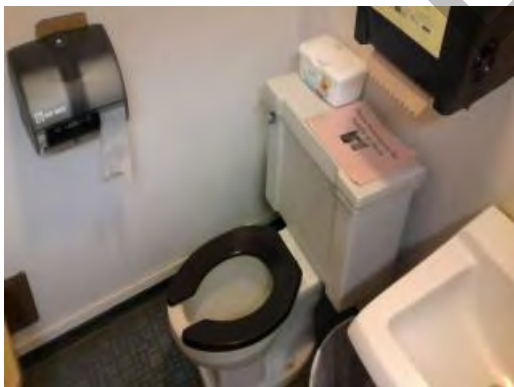
Typical Toilet Fixture

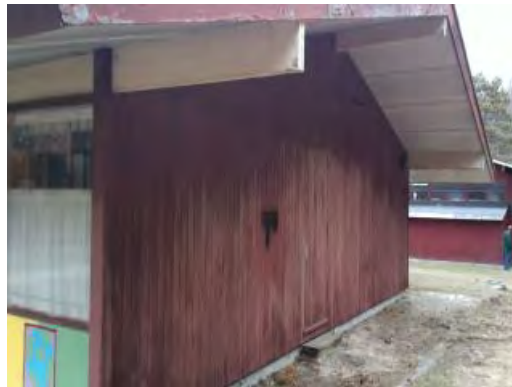
Exterior Wood Panel

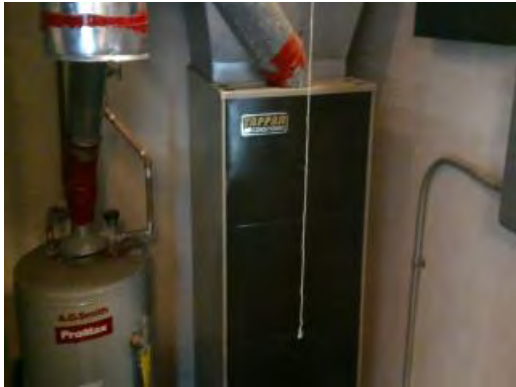
Furnace

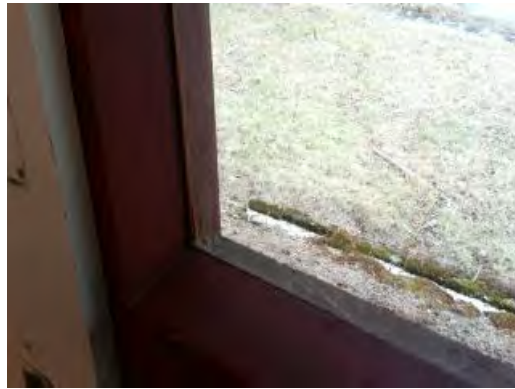
Typical Window

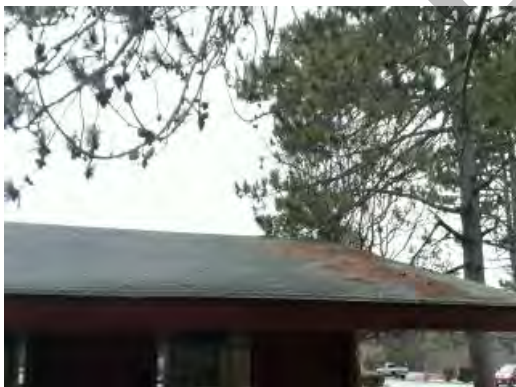
Composition Roof

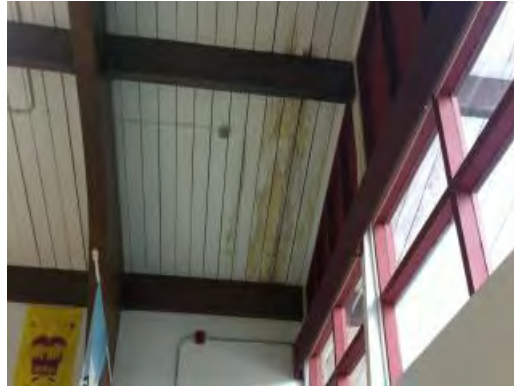
Stained Wood Decking

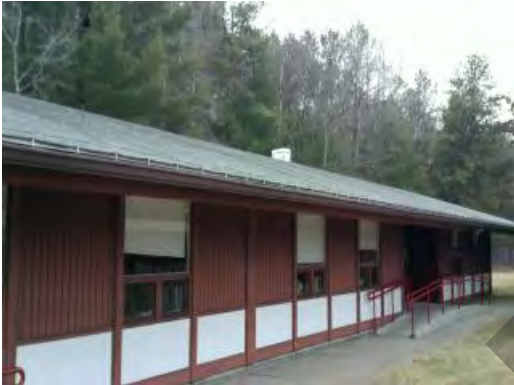
Exterior Finishes

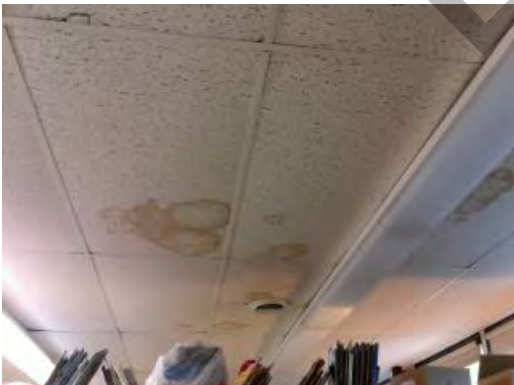
Original Grid System

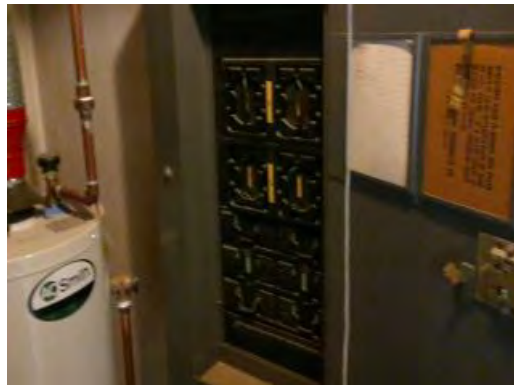
Aged Panelboard

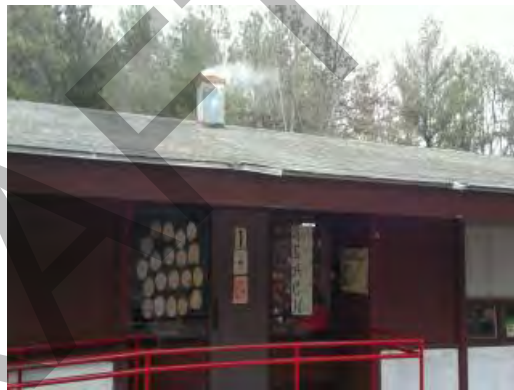
Shingle Roof

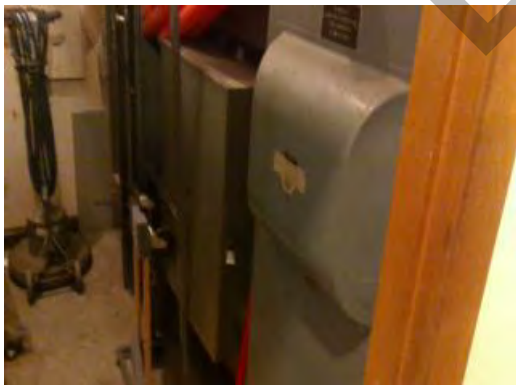
Main Disconnect

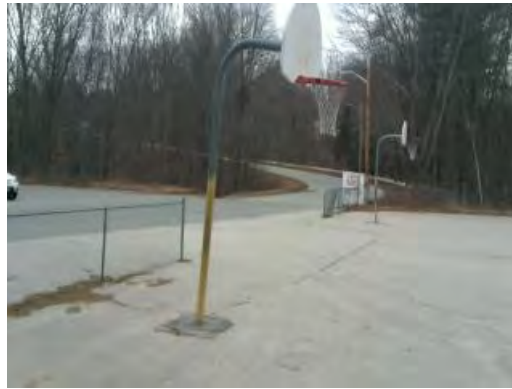
Basketball Goal

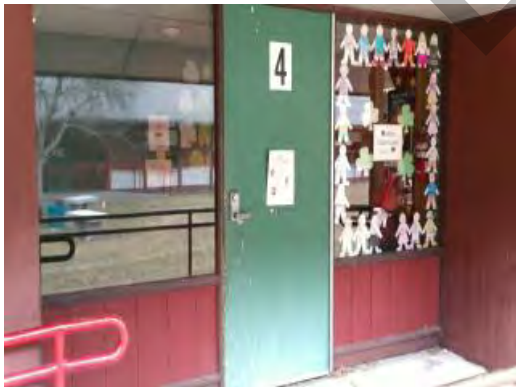
Exterior Door

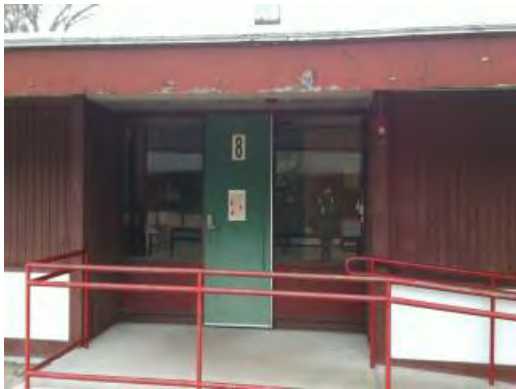
Exterior Door

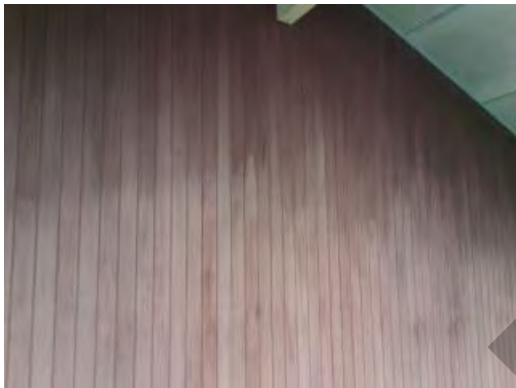
Typical Wood Veneer Fading

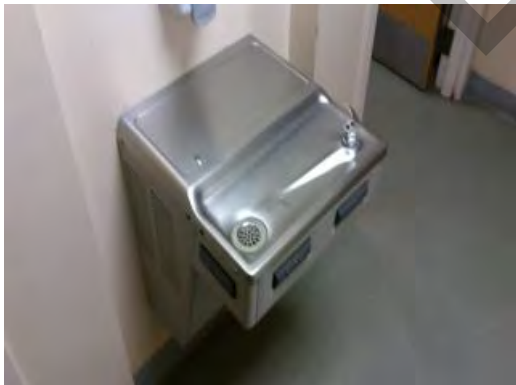
Water Fountain

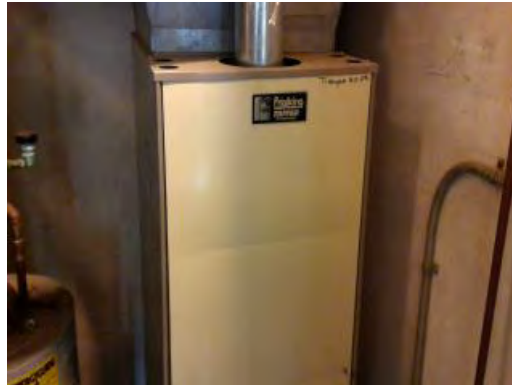
Furnace

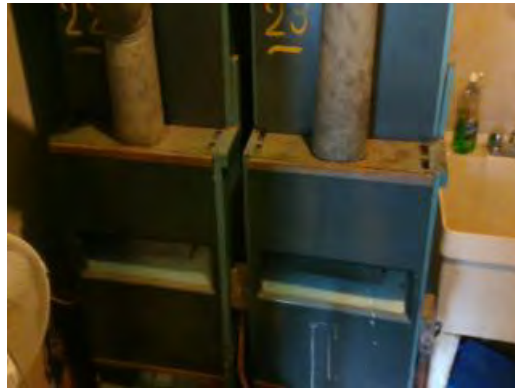
Aged Furnaces

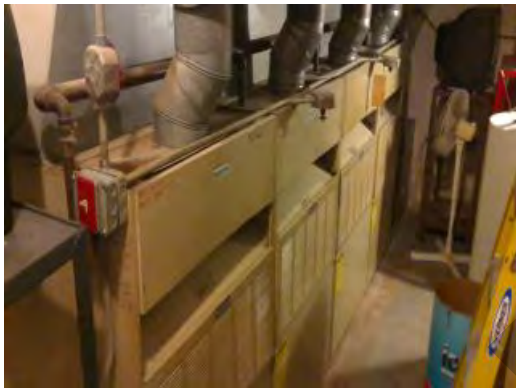
Gym Furnaces

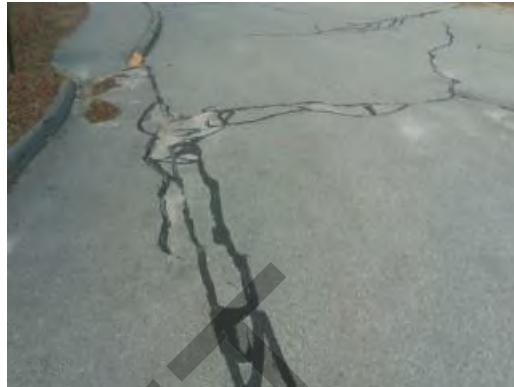
Deficiency	Category	Qty	UoM	Priority	Repair Cost	ID
Asphalt Paving Requires Replacement Note: Cracking pavement	Capital Renewal	116	CAR	3	\$381,204	1530
Asphalt Paving Requires Replacement Note: Cracking, splitting, and failing.	Capital Renewal	146	CAR	3	\$479,791	1544
Concrete Walks Require Replacement Note: Cracked and broken.	Capital Renewal	5,200	SF	3	\$105,570	1886
Fencing Requires Replacement (4' Chain Link Fence) Note: Fence falling and requires replacement.	Capital Renewal	230	LF	3	\$14,769	1543
Install New Paving Note: Add second entrance from Mowry Farms Lane	Traffic	15,900	SF	3	\$330,314	4459
Asphalt Paving Requires Replacement Note: Paved play areas splitting and cracking.	Capital Renewal	95	CAR	4	\$312,193	1531
Backstops Require Replacement Note: Backstops Require Replacement	Educational Adequacy	1	Ea.	4	\$28,674	28526
Exterior Basketball Goals Require Replacement Note: Basketball goals are damaged.	Capital Renewal	2	Ea.	4	\$15,260	1542

Damaged Asphalt

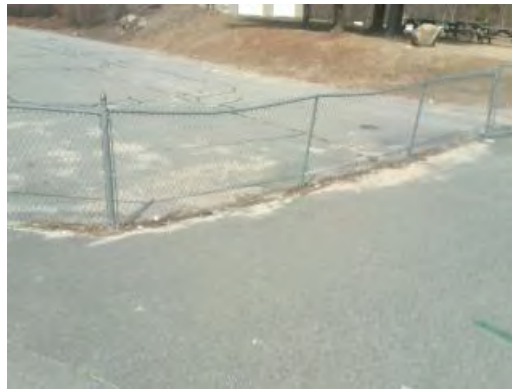
Damaged Fence

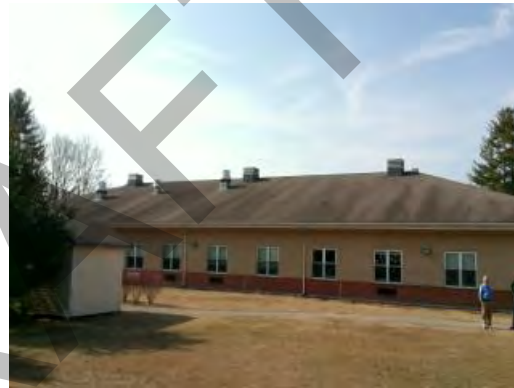
Deficiency	Category	Qty	UoM	Priority	Repair Cost	ID
EPDM Roofing Requires Replacement (Bldg SF) Note: Original roof.	Capital Renewal	5,000	SF	1	\$62,796	1554
Shingle Roof Requires Replacement Note: Roof is original to both 1989 and 2002 buildings.	Capital Renewal	70,000	SF	1	\$1,983,020	1553
Sub Total for System		2	Items		\$2,045,815

Original Shingle Roof

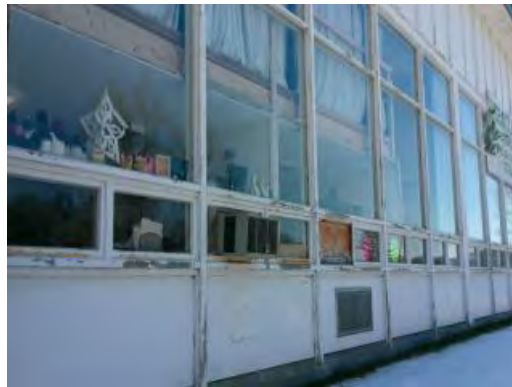
Main Building - Typical Original Wood Windows Weathered And Cracking

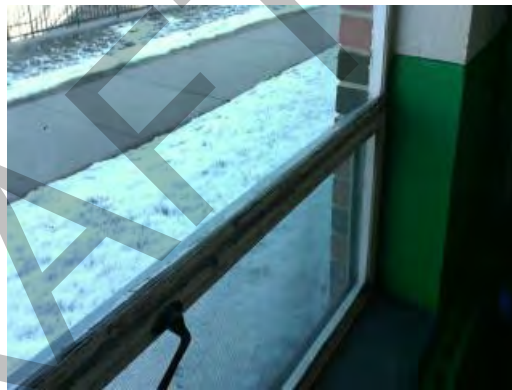
Main Building - Aged Single-Pane Window

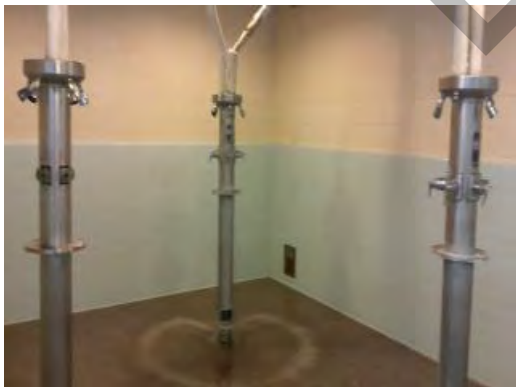
Main Building - Failing Shower Fixtures

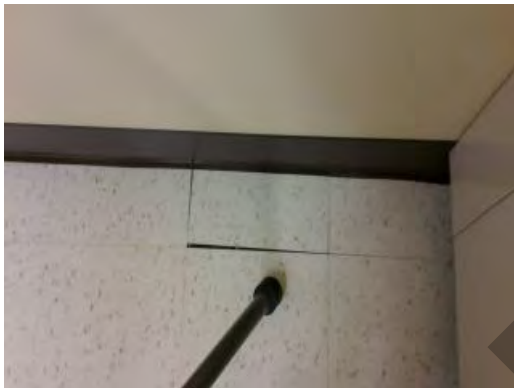
Separating Vinyl Tiles

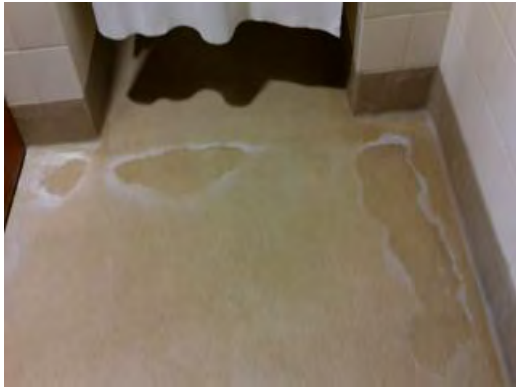
Water Damage Due To Floor Slope At Shower
