# North Smithfield

# Facility Condition Assessment

Dr. Harry L. Halliwell Memorial School, located at 358 Victory Highway in Slatersville, Rhode Island, was built in 1957. It comprises 41,175 gross square feet. Each school across the district was visited three times during the Facility Condition Assessments by three teams of specialists in the spring/summer of 2016.

North Smithfield - Dr. Harry L. Halliwell Memorial School

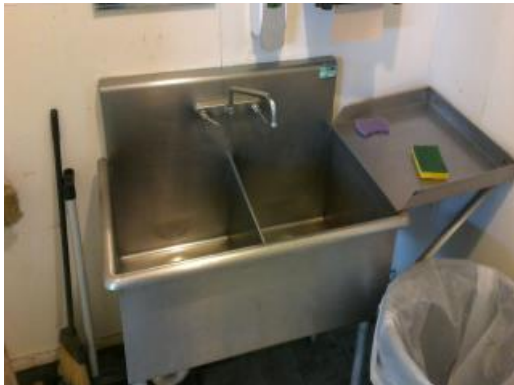
Kitchen Sink

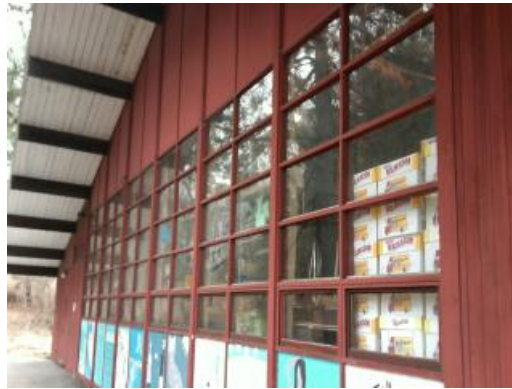
Exterior Windows

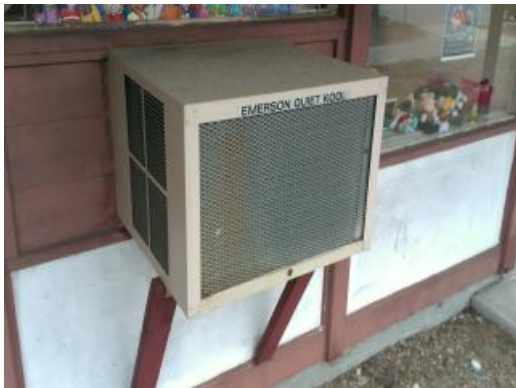
Window Unit

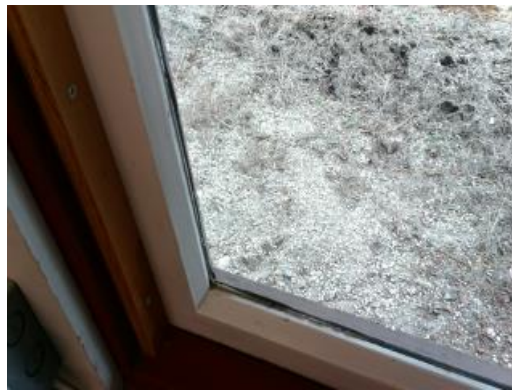
Single Pane Window

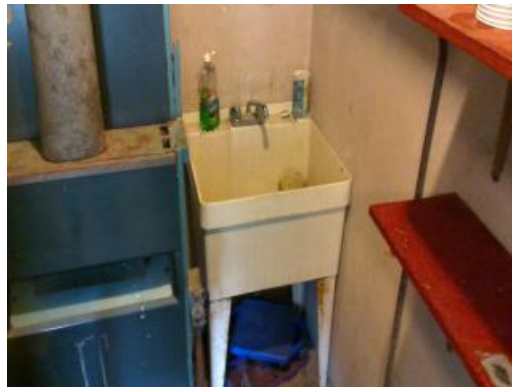
Mop Sink

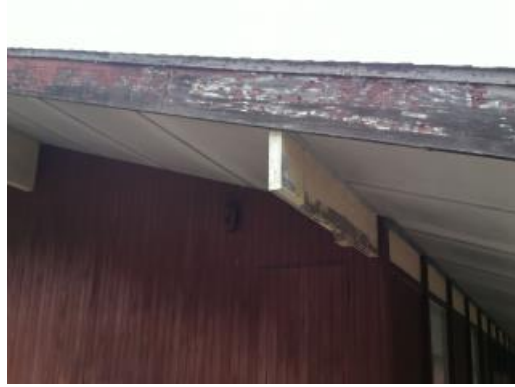
Wood Exterior

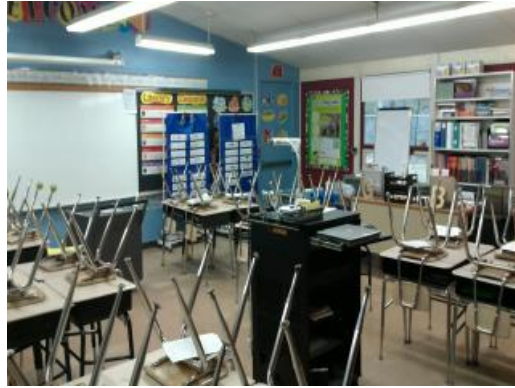
Typical Classroom

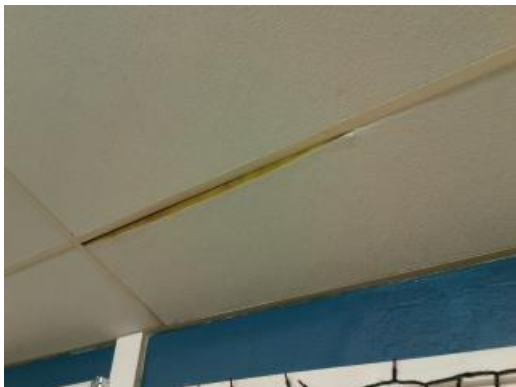
Typical Acoustic Tile

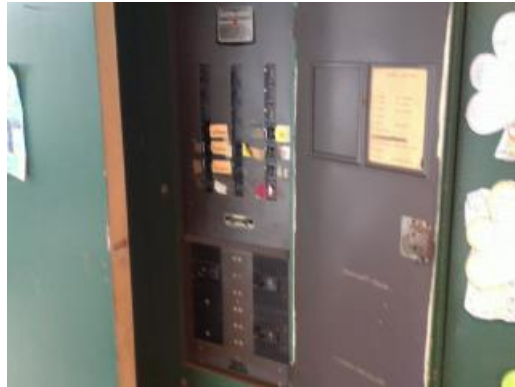
Aged Panelboard

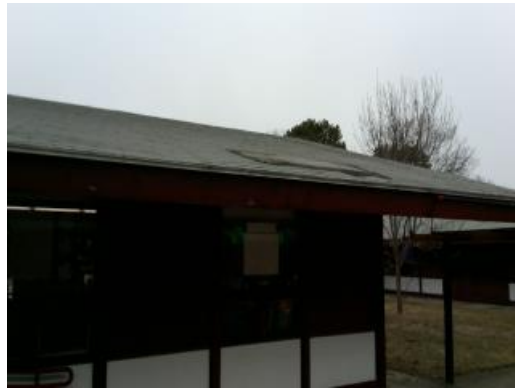
Building 4 Roof

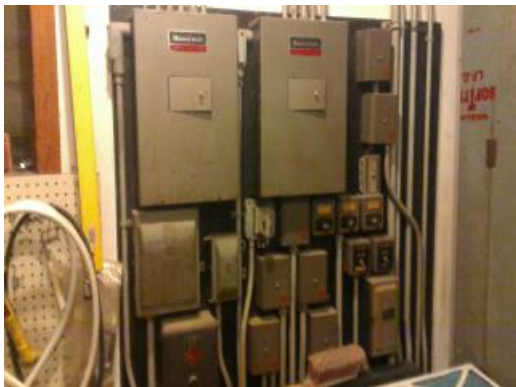
Rudimentary ECS

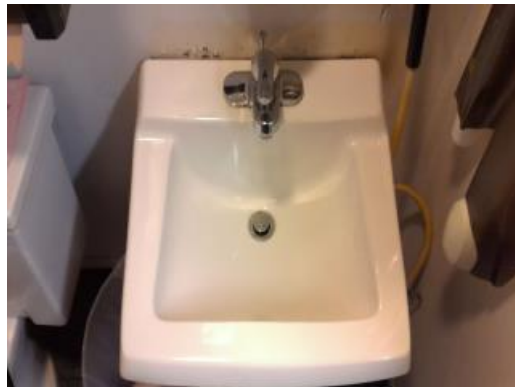
Lavatory

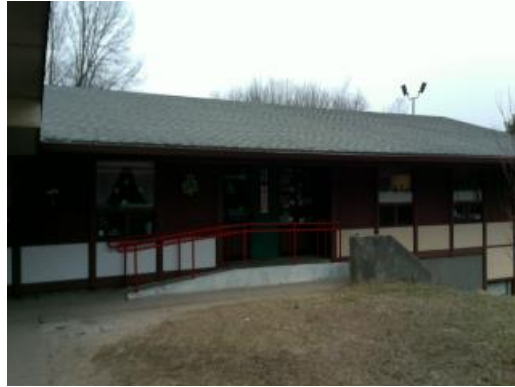
Building 8 Roof

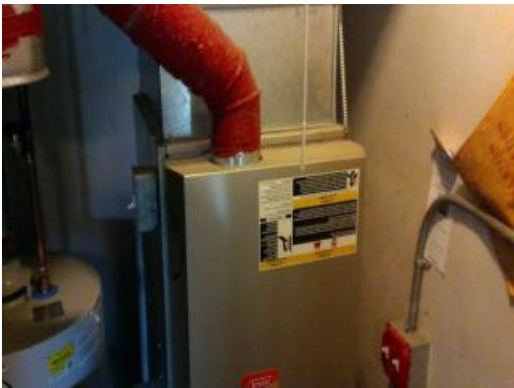
Furnace

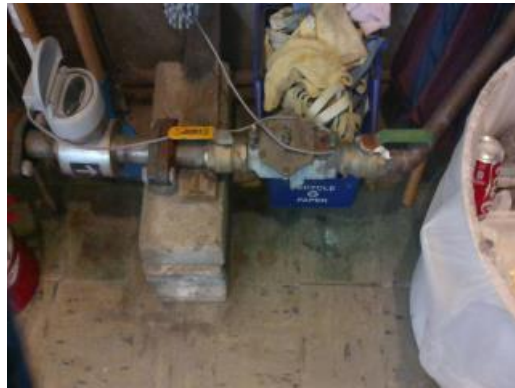
Backflow Preventer

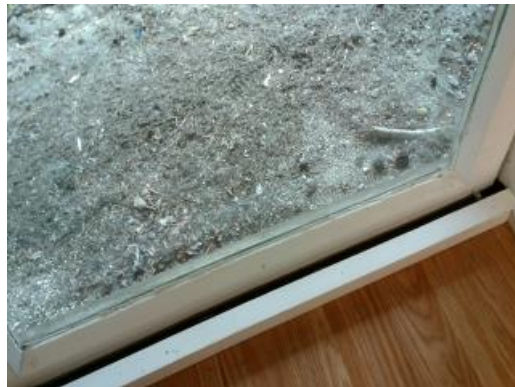
Typical Window

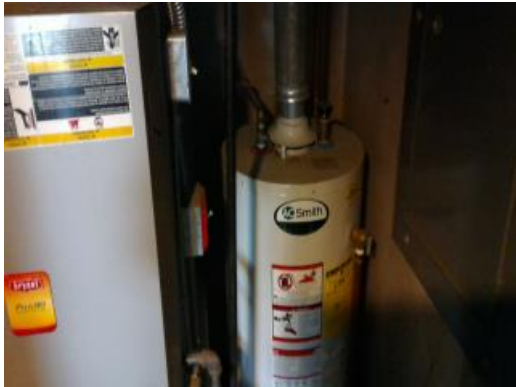
Water Heater

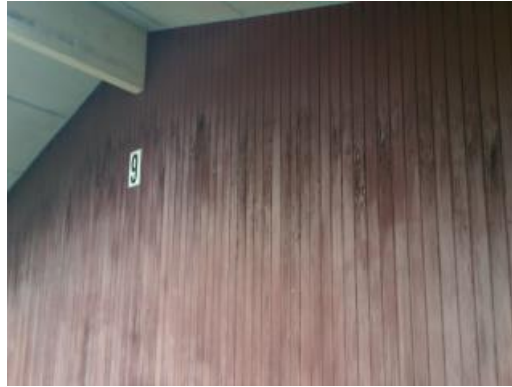
Weathered Wood Exterior

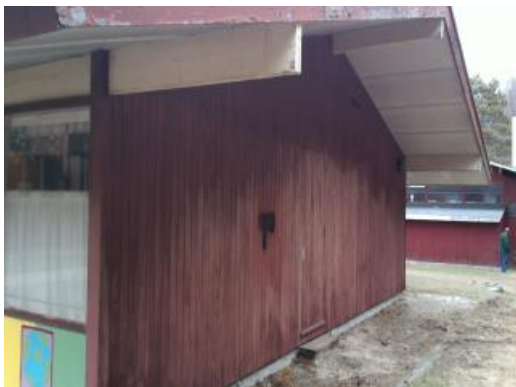
Exterior Wood Panel

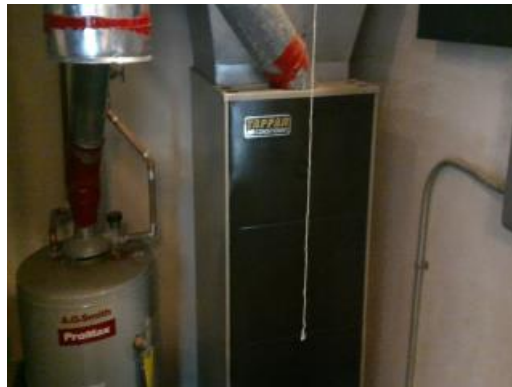
Furnace

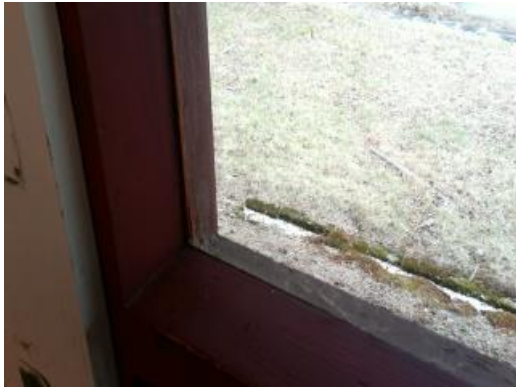
Typical Window

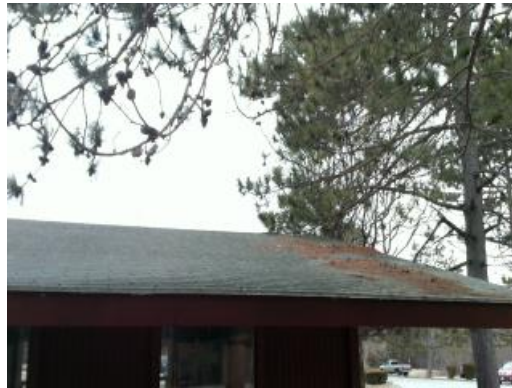
Composition Roof

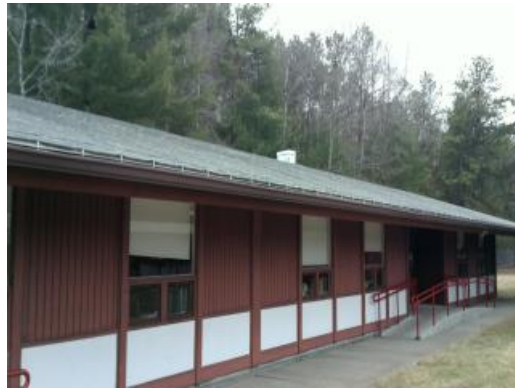
Exterior Finishes

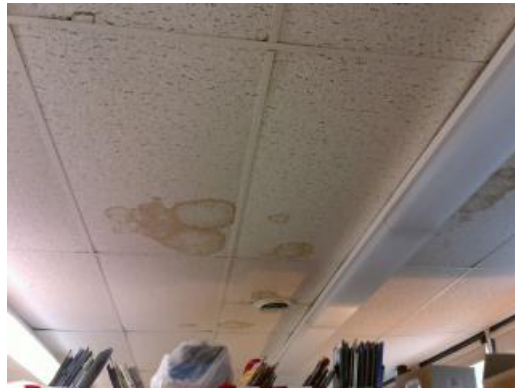
Original Grid System

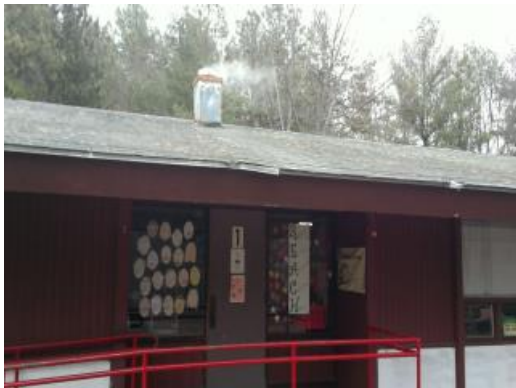
Shingle Roof

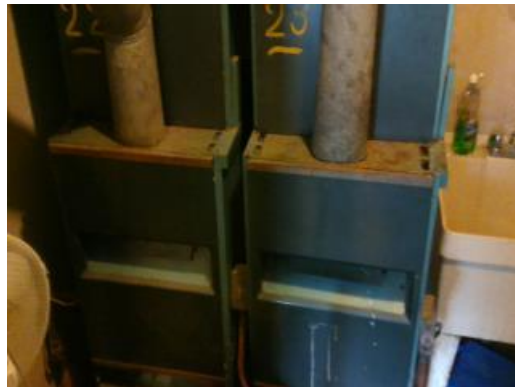
Aged Furnaces

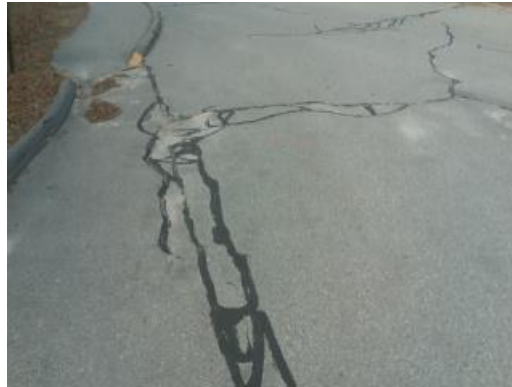
Damaged Asphalt

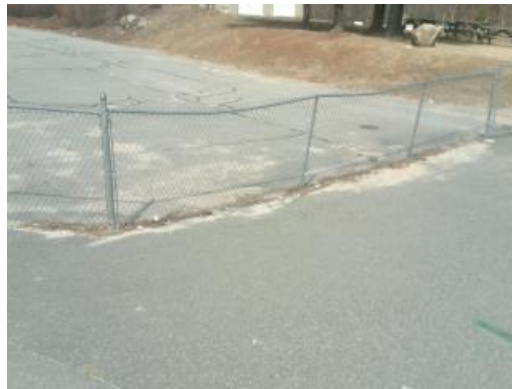
Damaged Fence

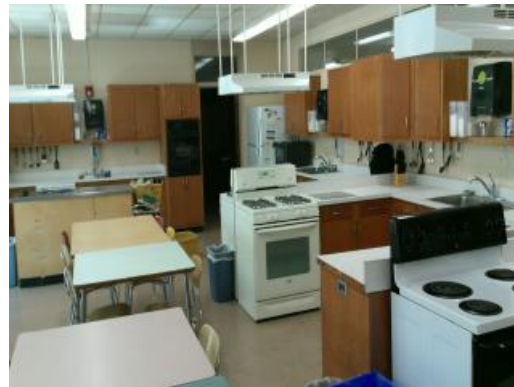
Main Building - Consumer Science Classroom

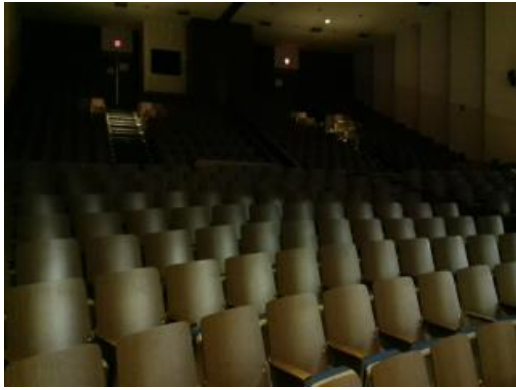
Main Building - Auditorium

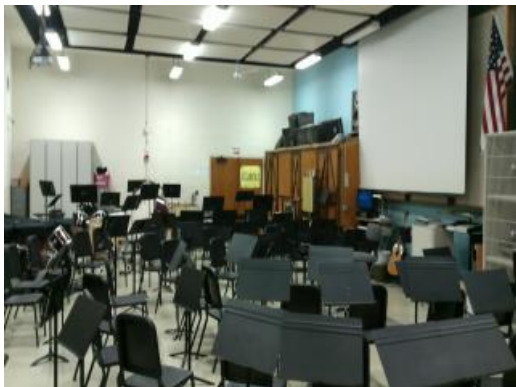
Main Building - Band Room

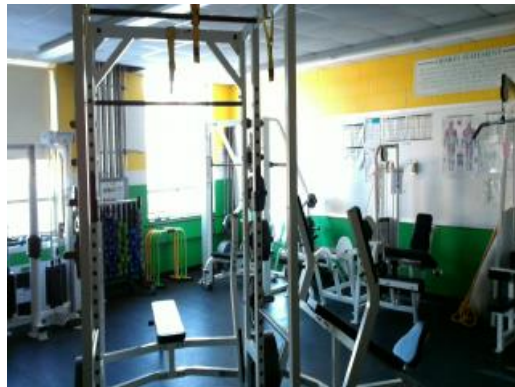
Main Building - Weight Room

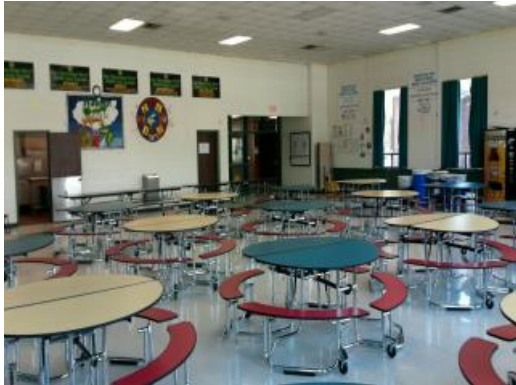
Main Building - Cafeteria

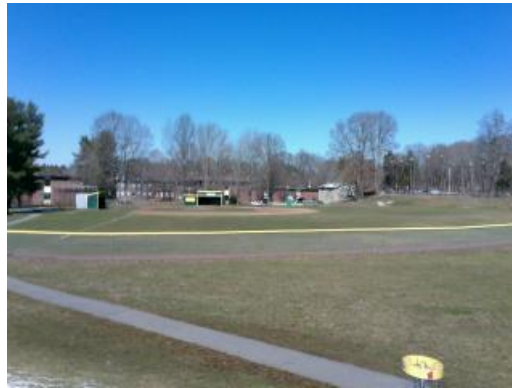
Site - Baseball Field

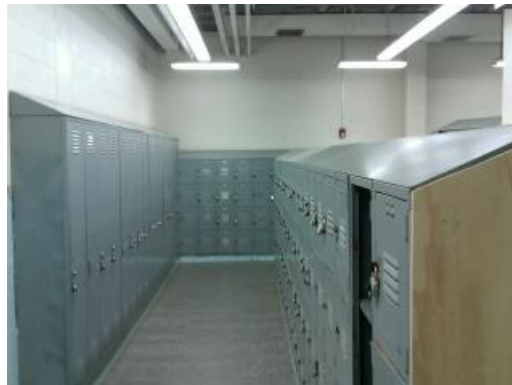
Main Building - Boys Locker Room

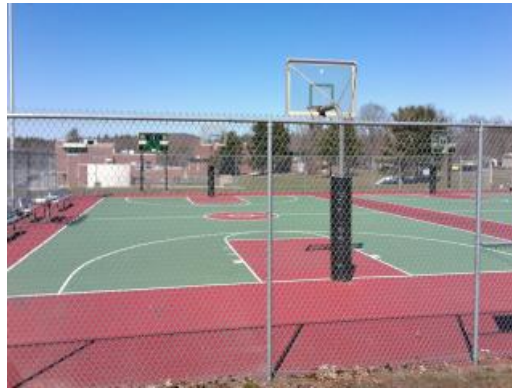
Site - Basketball Courts

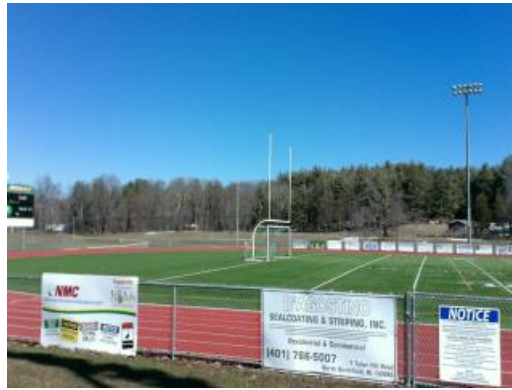
Site - Track And Field

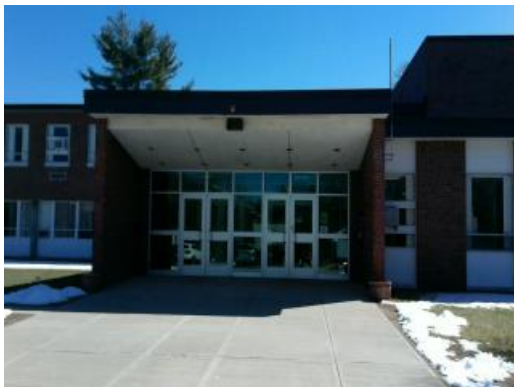
Main Building - Entrance

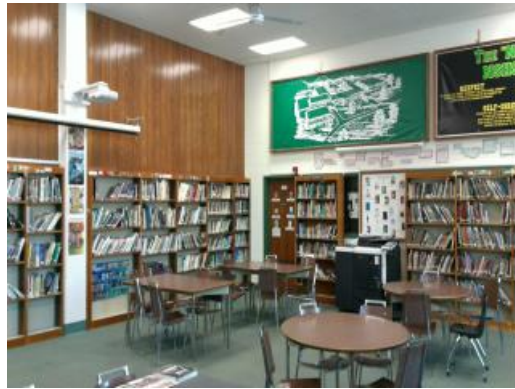
Main Building - Library

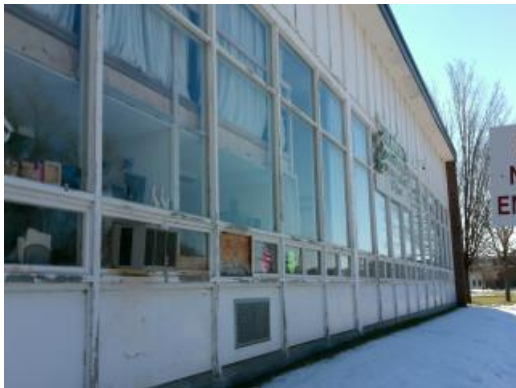
Main Building - Cafeteria Exterior

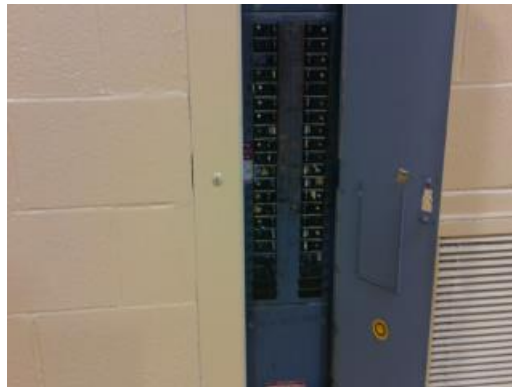
Main Building - Typical Aged Panelboard

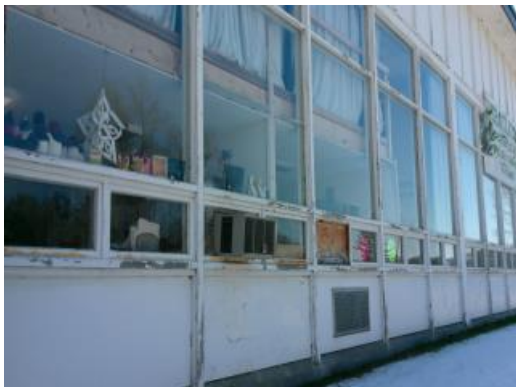
Main Building - Typical Original Wood Windows Weathered And Cracking

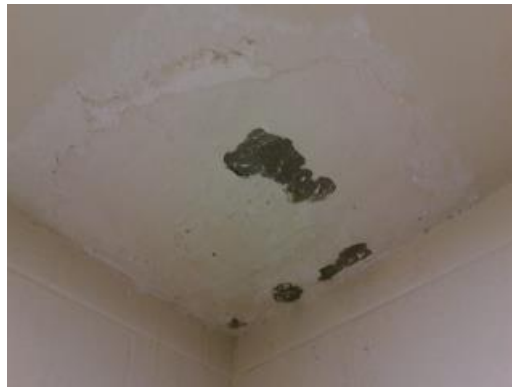
Main Building - Paint Peeling And Bubbling On Ceiling

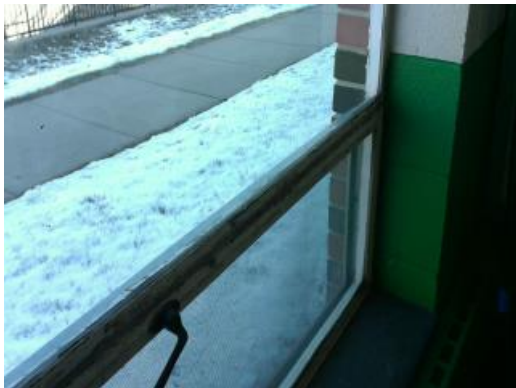
Main Building - Aged Single-Pane Window
